Re: January 2014, Monthly Water Column Monitoring Report Submittal
San Diego Shipyard Sediment Site – South Shipyard
Place ID 794466, Order No. R9-2013-0093

TECHNICAL MEMORANDUM

Re: San Diego Shipyard Sediment Site – South Shipyard (Place ID 794466, Order No. R9-2013-0093) Monthly Water Column Monitoring Report: January 2014

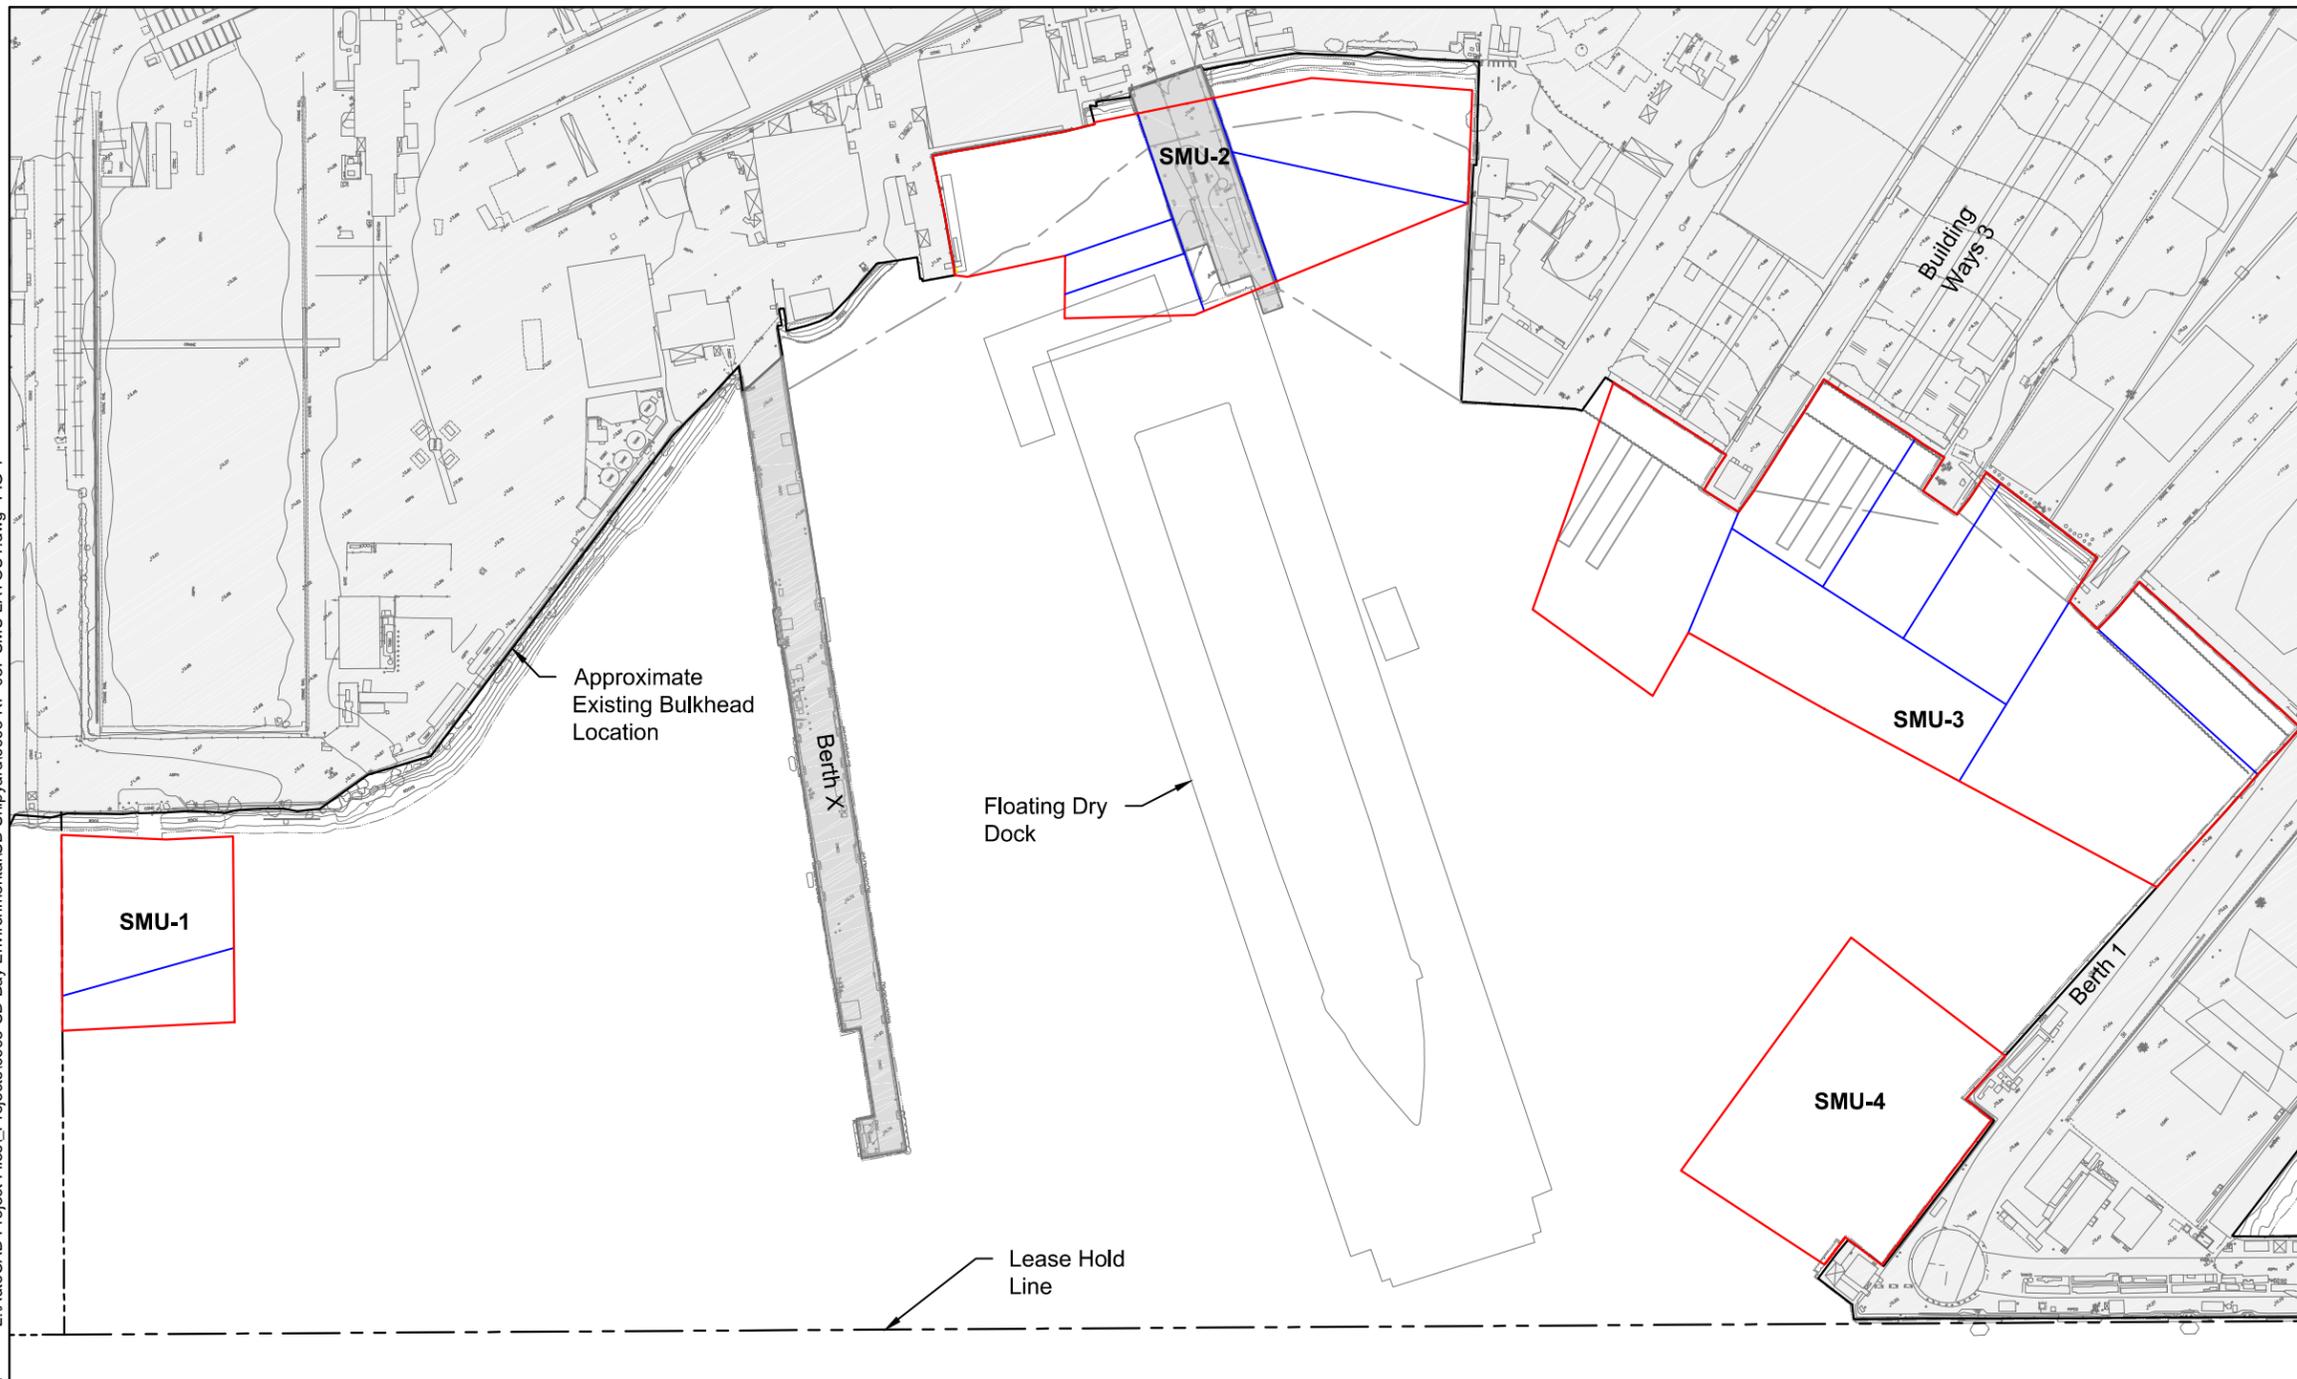
L:\AutoCAD Project Files\Projects\0995-SD Bay Environmental\SD Shipyard\0995-RP-037 SMU LAYOUT.dwg FIG 1

In January, 4,850 cubic yards (cy) of sediment was dredged from within Sediment Management Unit (SMU)-2 (Figure 1). Daily production rates ranged from 50 to 600 cy. All sediment was disposed of at the Otay Landfill. A summary of daily dredge volumes, locations from which sediment was removed, and final disposal locations is presented in Table 1. Waste manifests are provided in Attachment A.

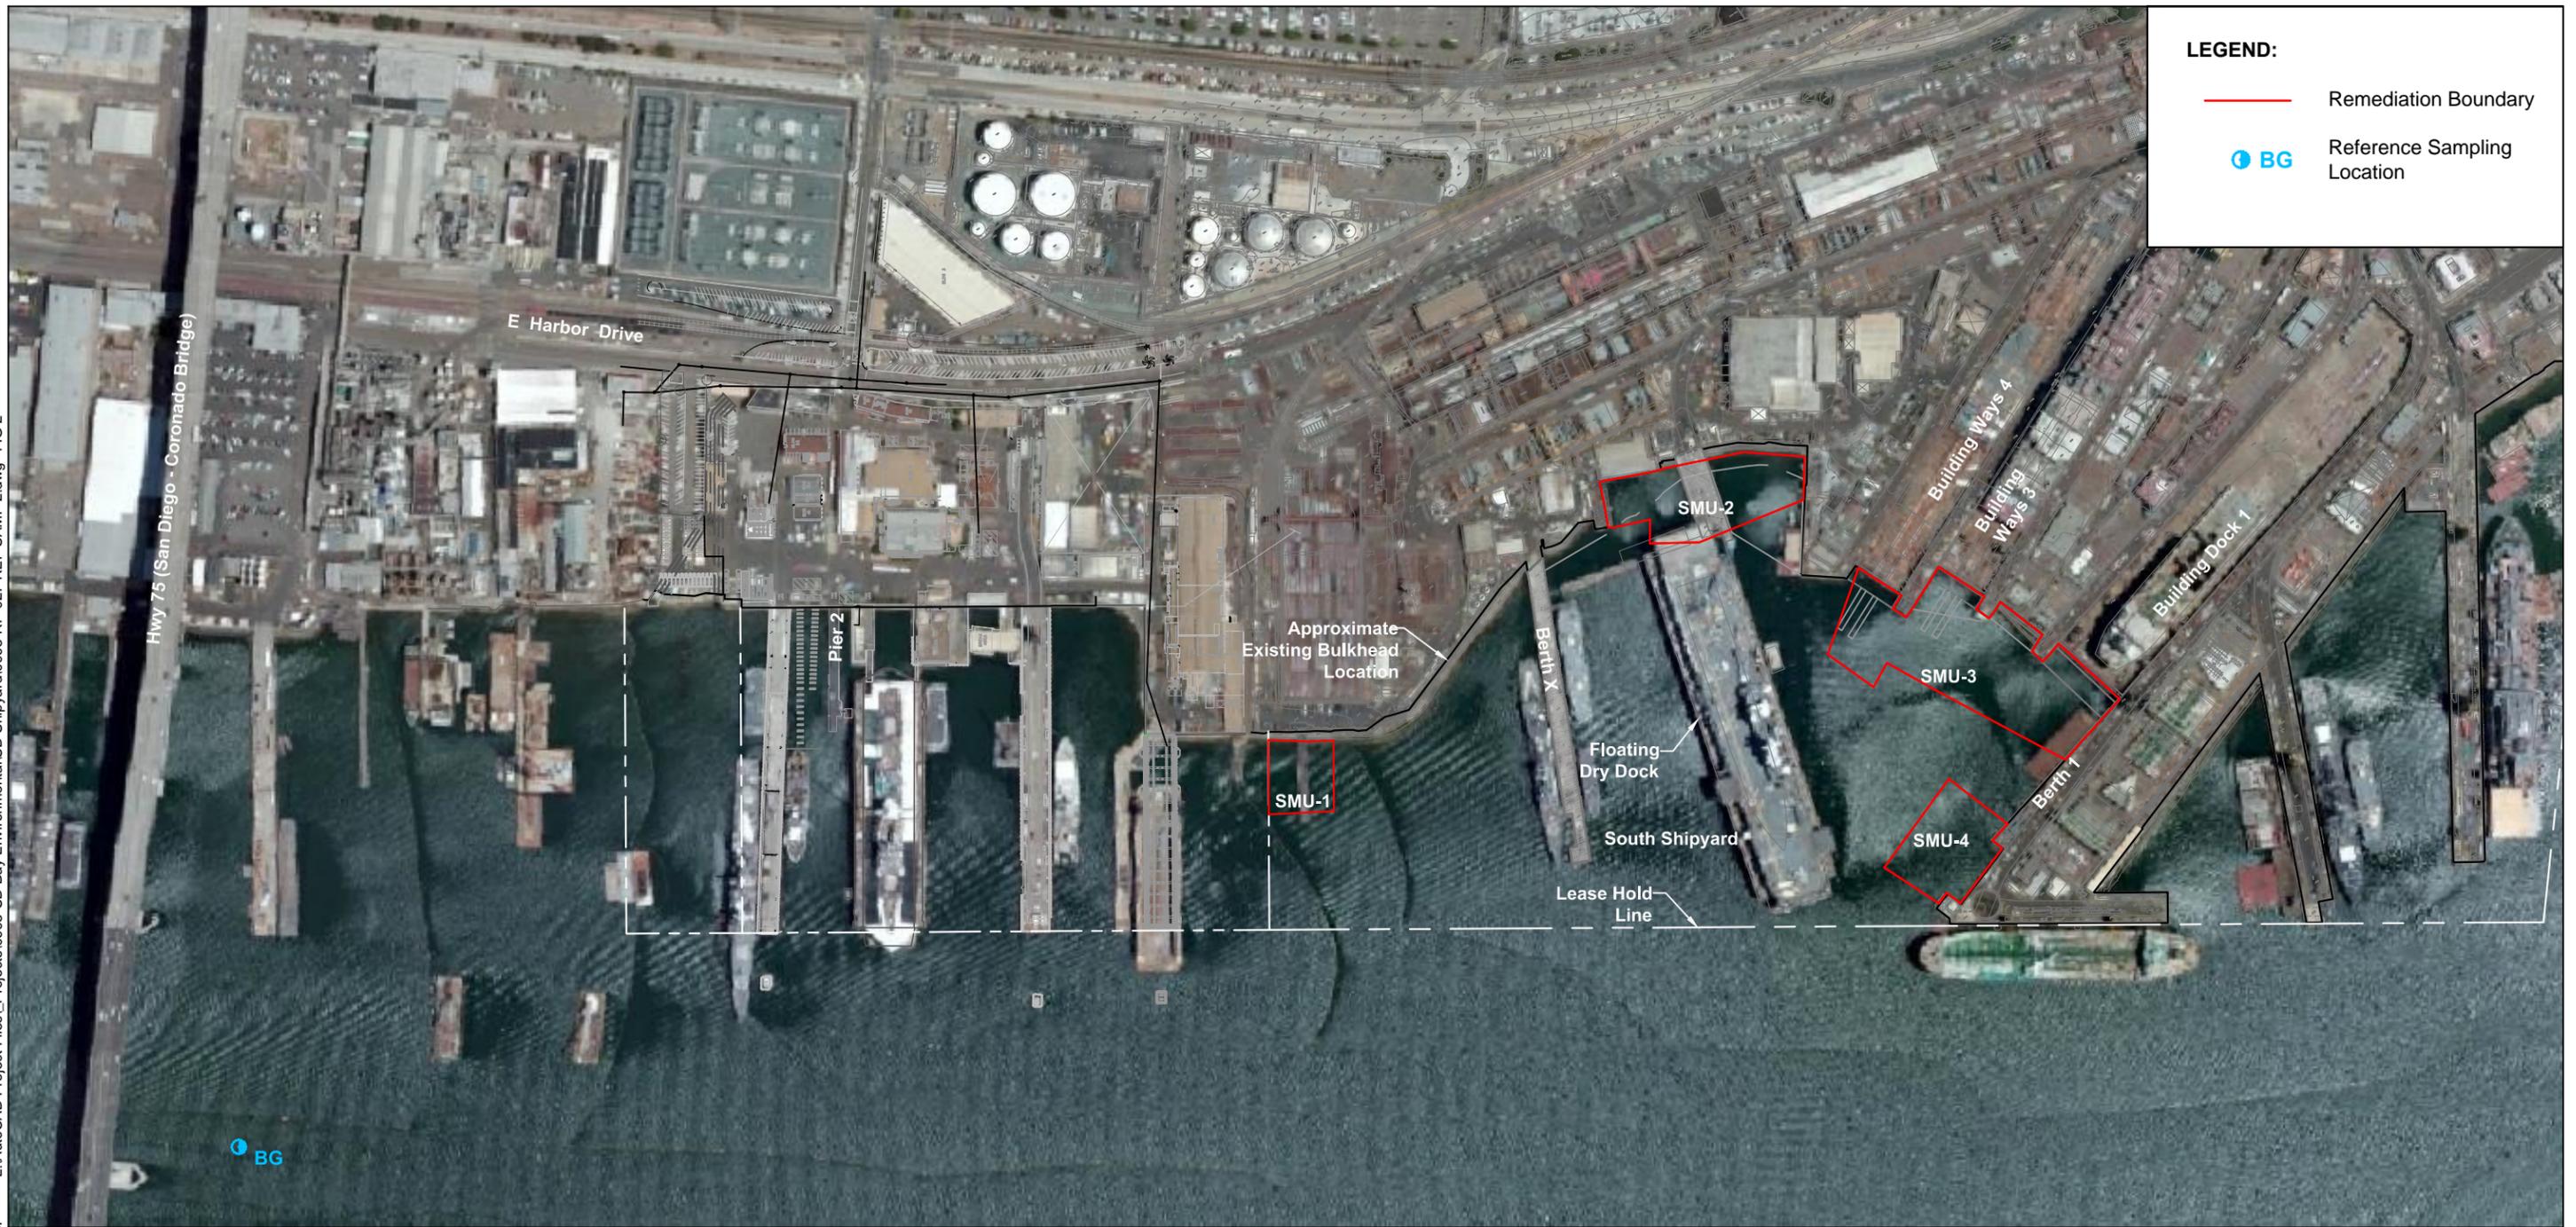
L:\AutoCAD Project Files\Projects\0995-SD Bay Environmental\SD Shipyard\0995-RP-027 REF SAMP 2.dwg FIG 2

Monitoring was performed at the reference station, two early warning stations, and four compliance stations. The reference station is located 1,000 feet from the remedial footprint in the direction of the ocean and beyond the influence of construction activities (Figure 2). Early warning and compliance stations are located 250 and 500 feet from the construction area, respectively. The general layout of early warning and compliance monitoring locations

NOTES:
 Reference Sampling Location BG
 Latitude: 32° 41.4970'
 Longitude: 117° 09.0185'

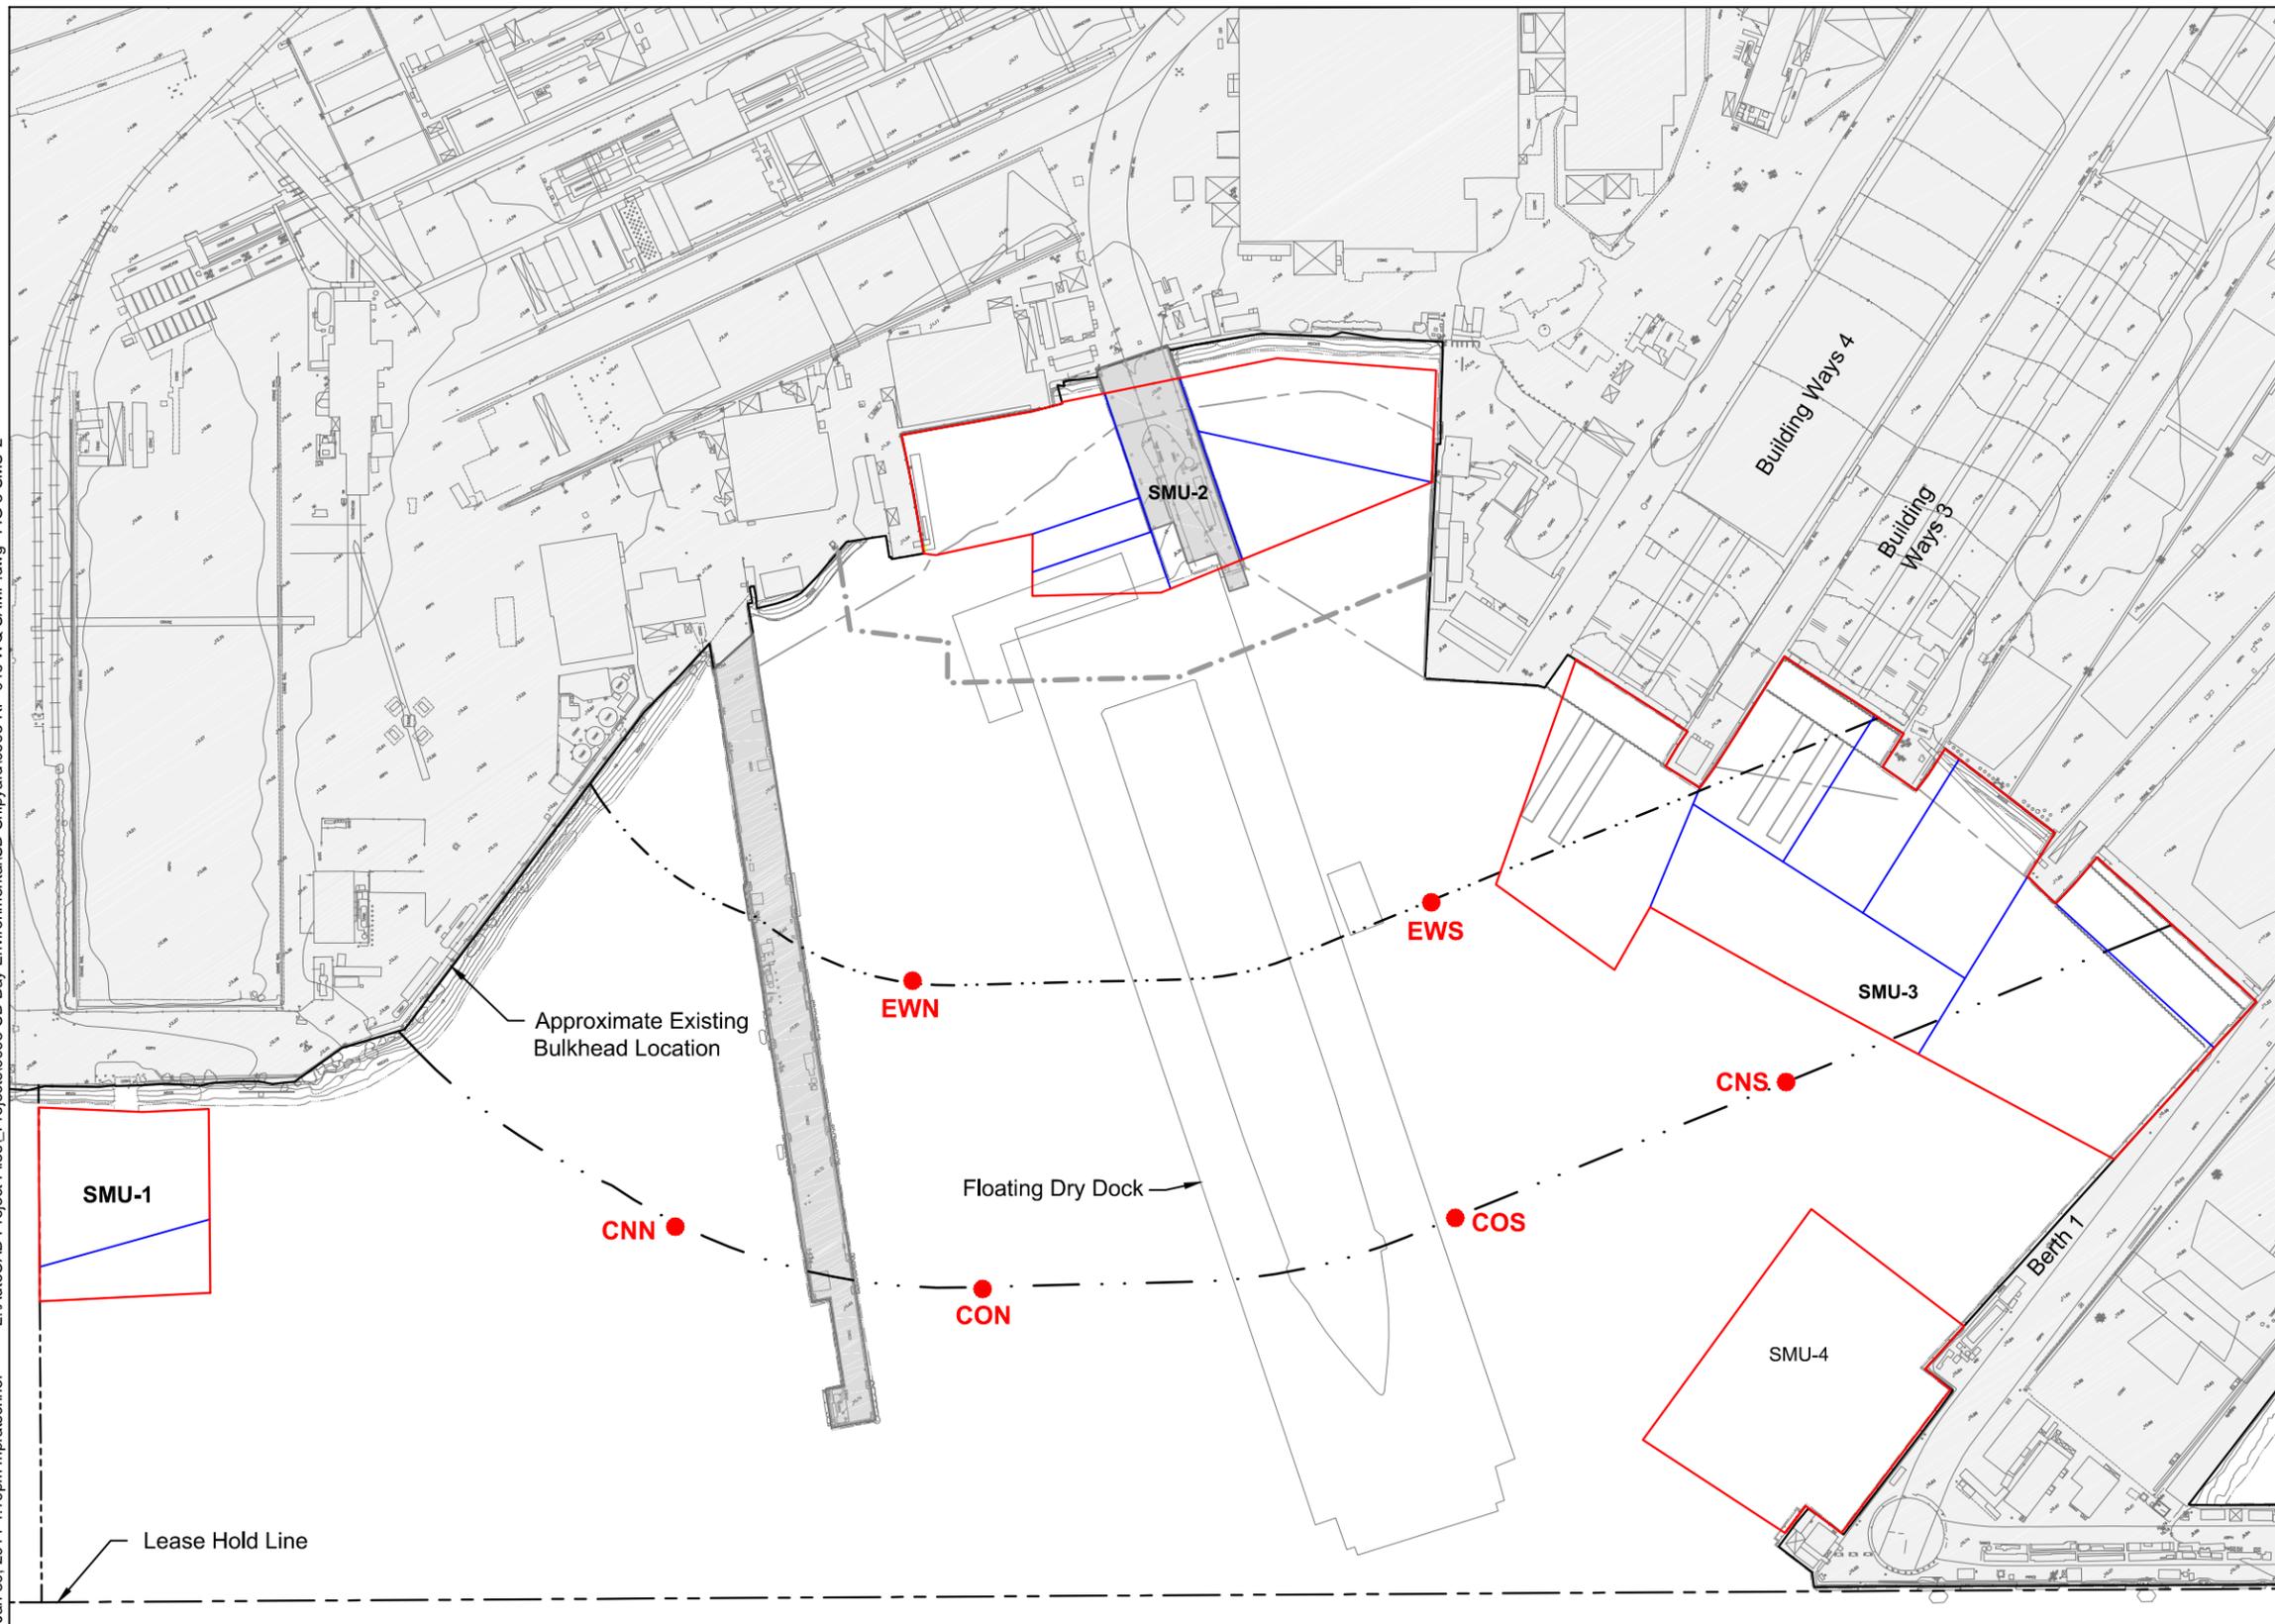
L:\AutoCAD Project Files\Projects\0995-SD Bay Environmental\SD Shipyard\0995-RP-046 WQ SAMP.dwg FIG 3 SMU-2
 Jan 30, 2014 4:19pm mpraichner

for SMU-2 is shown on Figure 3; however, actual locations were positioned in the field relative to the construction area. Latitude and longitude coordinates for each monitoring location are presented in Table 2.

NOTE: Actual sampling locations determined in the field based on the location of the construction area.

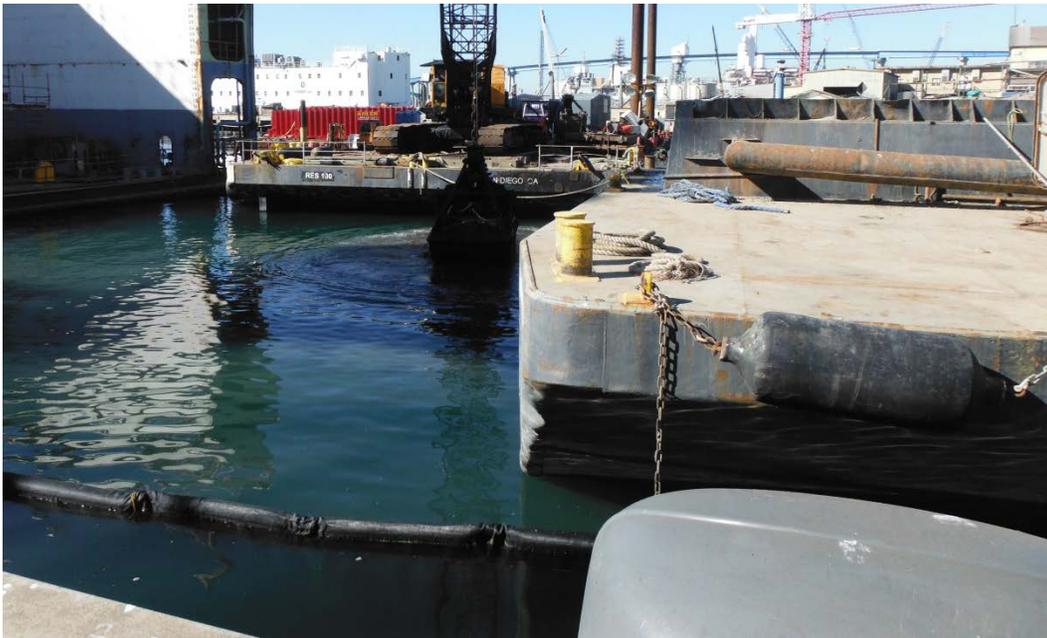
Visual observations are summarized in Table 2. No odors or visual evidence of discoloration, turbidity, or surface pollution was observed at any station. The double silt curtain was in place during all dredging operations, and no damage, dislocation, or gaps were observed.

Visual monitoring of turbidity inside and outside the silt curtains was performed in concert with water quality parameter monitoring. Attachment D provides site photographs of the silt curtains that visualize typical conditions during construction, showing an attenuating turbidity plume inside the two silt curtains. These visual observations are consistent with the results presented in this technical memorandum.

View northwest of silt curtains at SMU-2, January 14, 2014

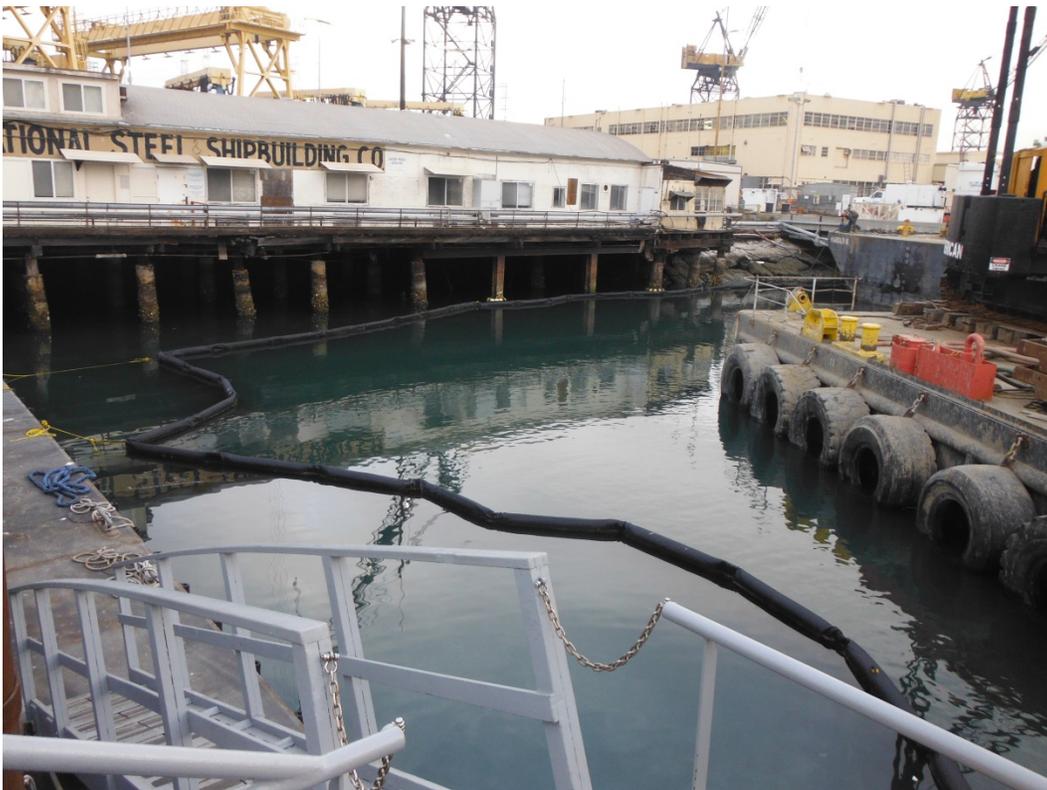
View northeast of silt curtains at SMU-2, January 21, 2014
