TECHNICAL MEMORANDUM

Re: San Diego Shipyard Sediment Site – South Shipyard (Place ID 794466, Order No.
R9-2013-0093) Monthly and Weekly Biological and Environmental Monitoring
Report: January 1 to February 1, 2014

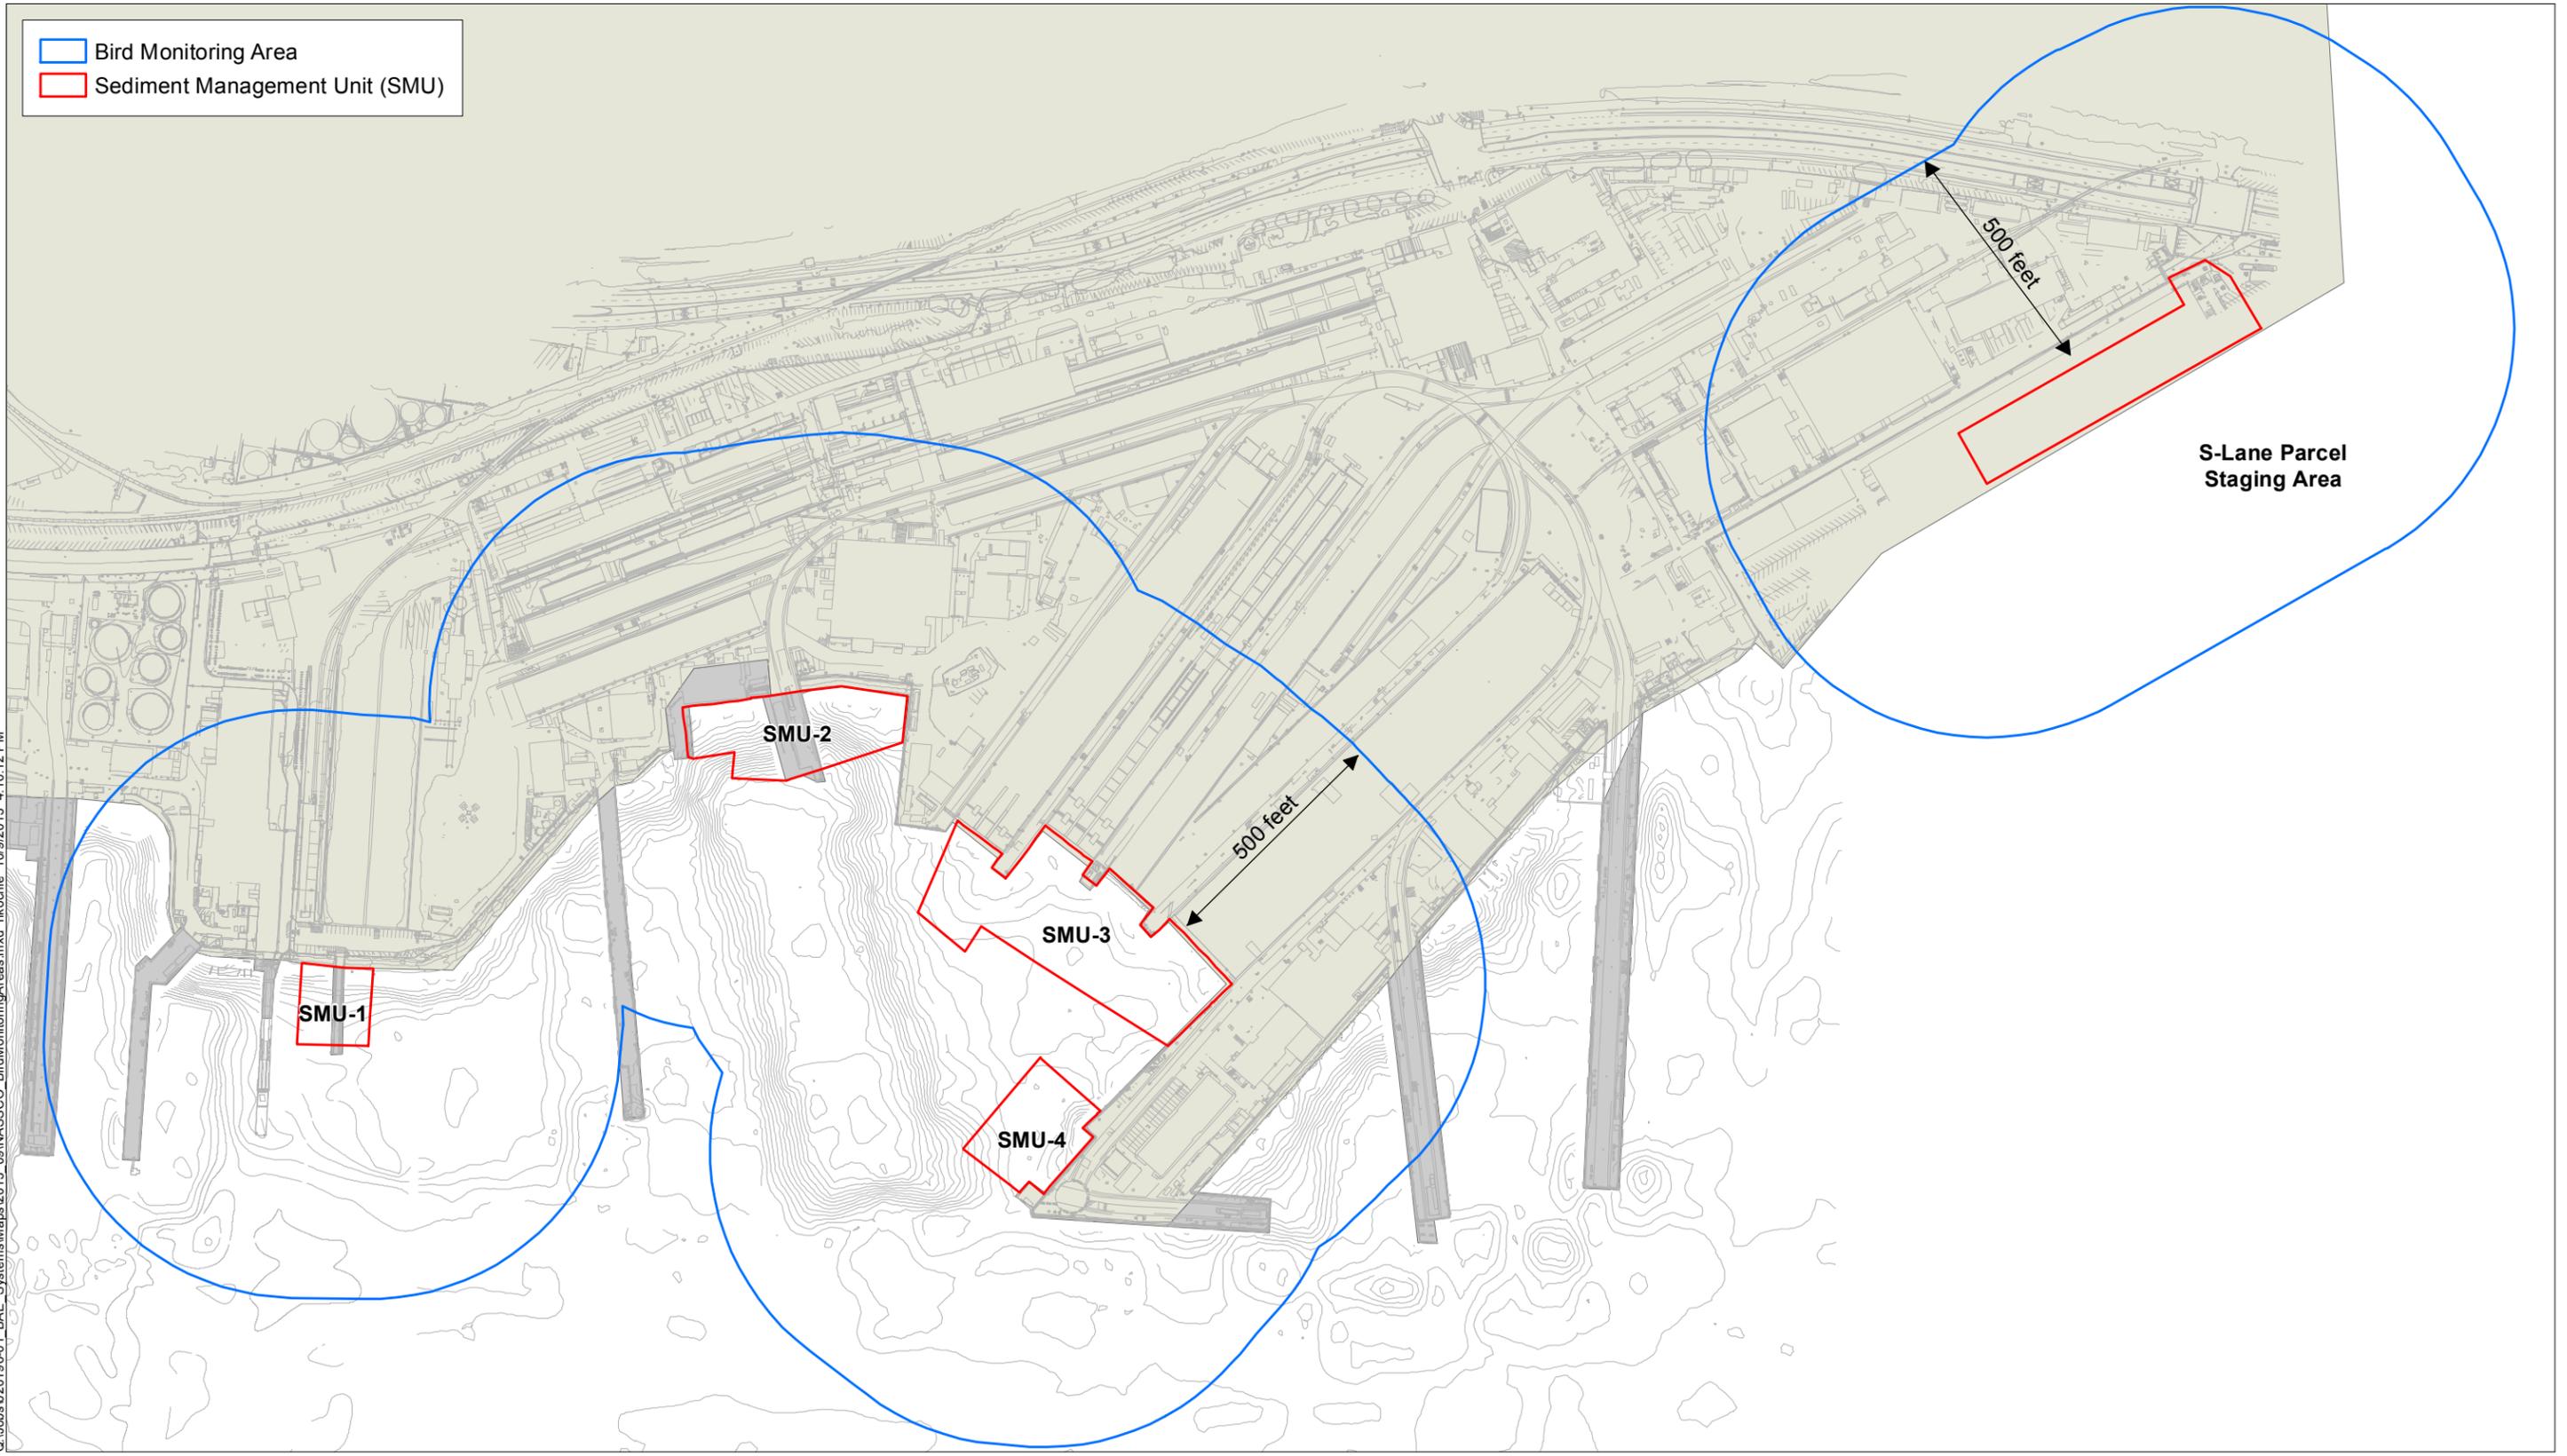
Figure 1
Special Status Bird Monitoring Areas
San Diego Shipyard Sediment Site – South Shipyard

Weekly special status bird monitoring occurred on January 3, 9, 15, 22, and 31. Observations were conducted within monitoring areas as identified on Figure 1, which correspond to approximately 500 feet surrounding anticipated construction activities. No California least terns were observed during weekly monitoring. Multiple double-crested cormorants were observed; one in SMU-2 on January 9, five in SMU-1 on January 15, eleven in SMU-1 on January 22, and two in SMU-1 on January 31. No disturbance was noted. Details of these observations are presented in Attachment A.
