TECHNICAL MEMORANDUM

Re: San Diego Shipyard Sediment Site – South Shipyard (Place ID 794466, Order No. R9-2013-0093) Weekly Water Column Monitoring Report: October 14 to 19, 2013

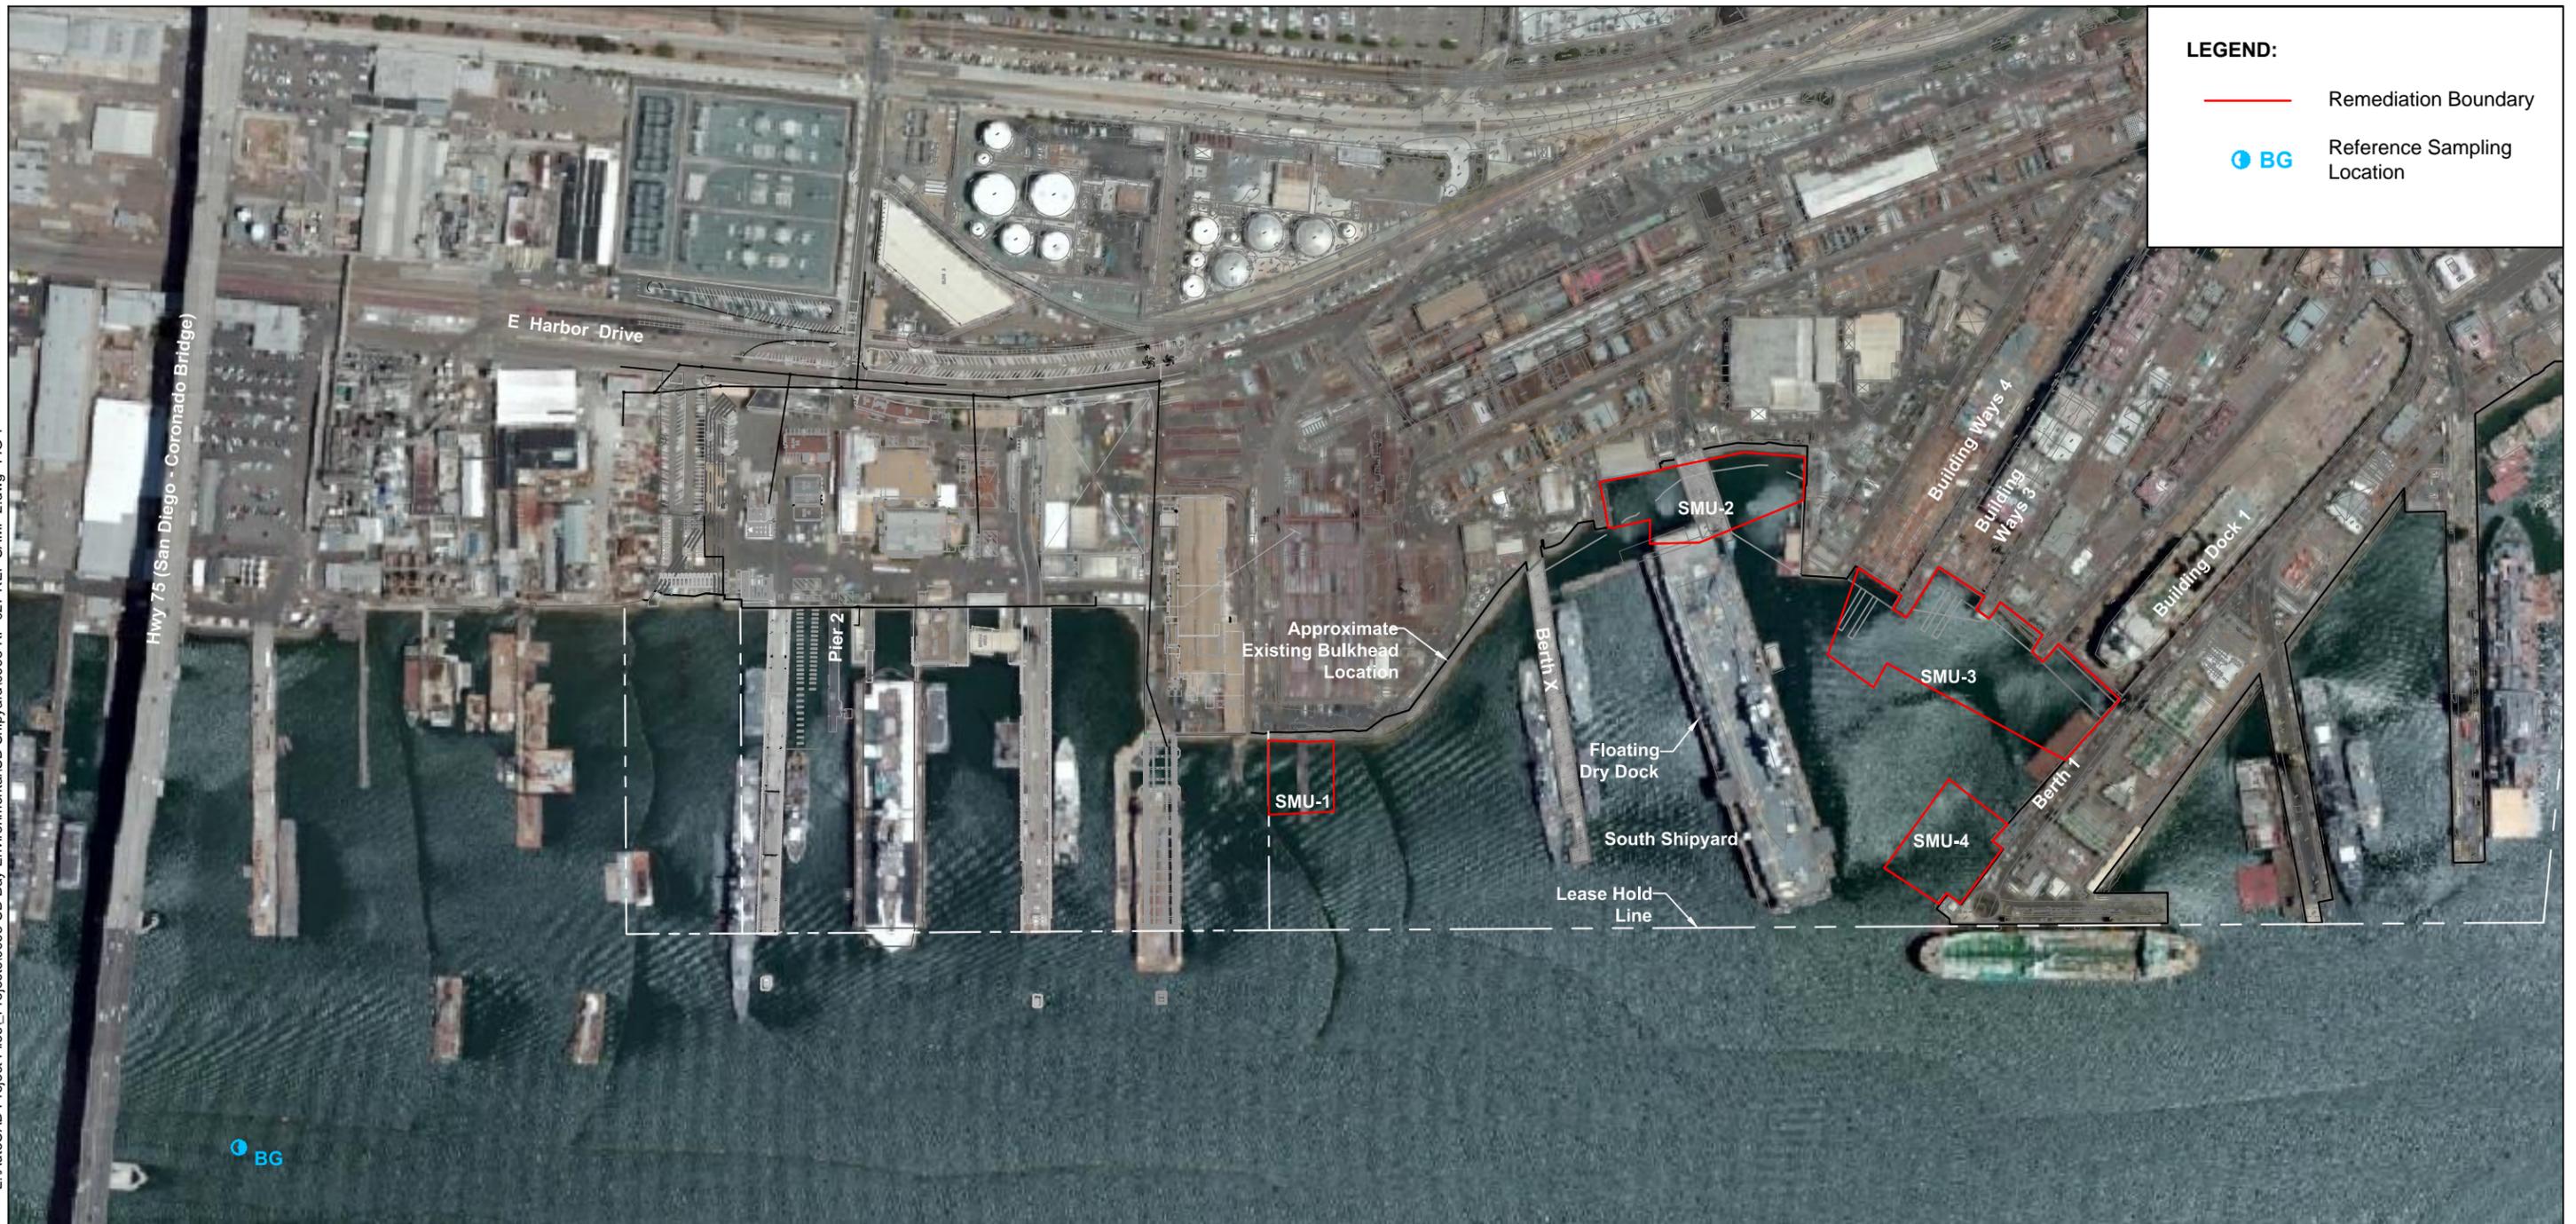
L:\AutoCAD Project Files\Projects\0995-SD Bay Environmental\SD Shipyard\0995-RP-027 REF SAMP 2.dwg FIG 1

SOURCE: Aerial from ESRI base maps. Upland topography from Digital Mapping Inc., dated September 2009, and supplemented by Environmental Data Solutions survey dated April 13, 2013.
HORIZONTAL DATUM: California State Plane, Zone 6, NAD83, U.S. Feet.

NOTES:
 Reference Sampling Location BG
 Latitude: 32° 41.4970'
 Longitude: 117° 09.0185'

DO, pH, and turbidity were measured 10 feet below the surface at each station using a Hydrolab MS5 multi-probe sonde. Monitoring was performed at the reference station, two early warning stations, and four compliance stations. The reference station was located 1,000 feet from the remedial footprint in the direction of the ocean (Figure 1). Early warning and compliance stations were located 250 and 500 feet from the construction area, respectively. The general layout of early warning and compliance monitoring locations for Sediment Management Unit (SMU)-4 are shown on Figure 2; however, actual locations were positioned in the field relative to the construction area.¹

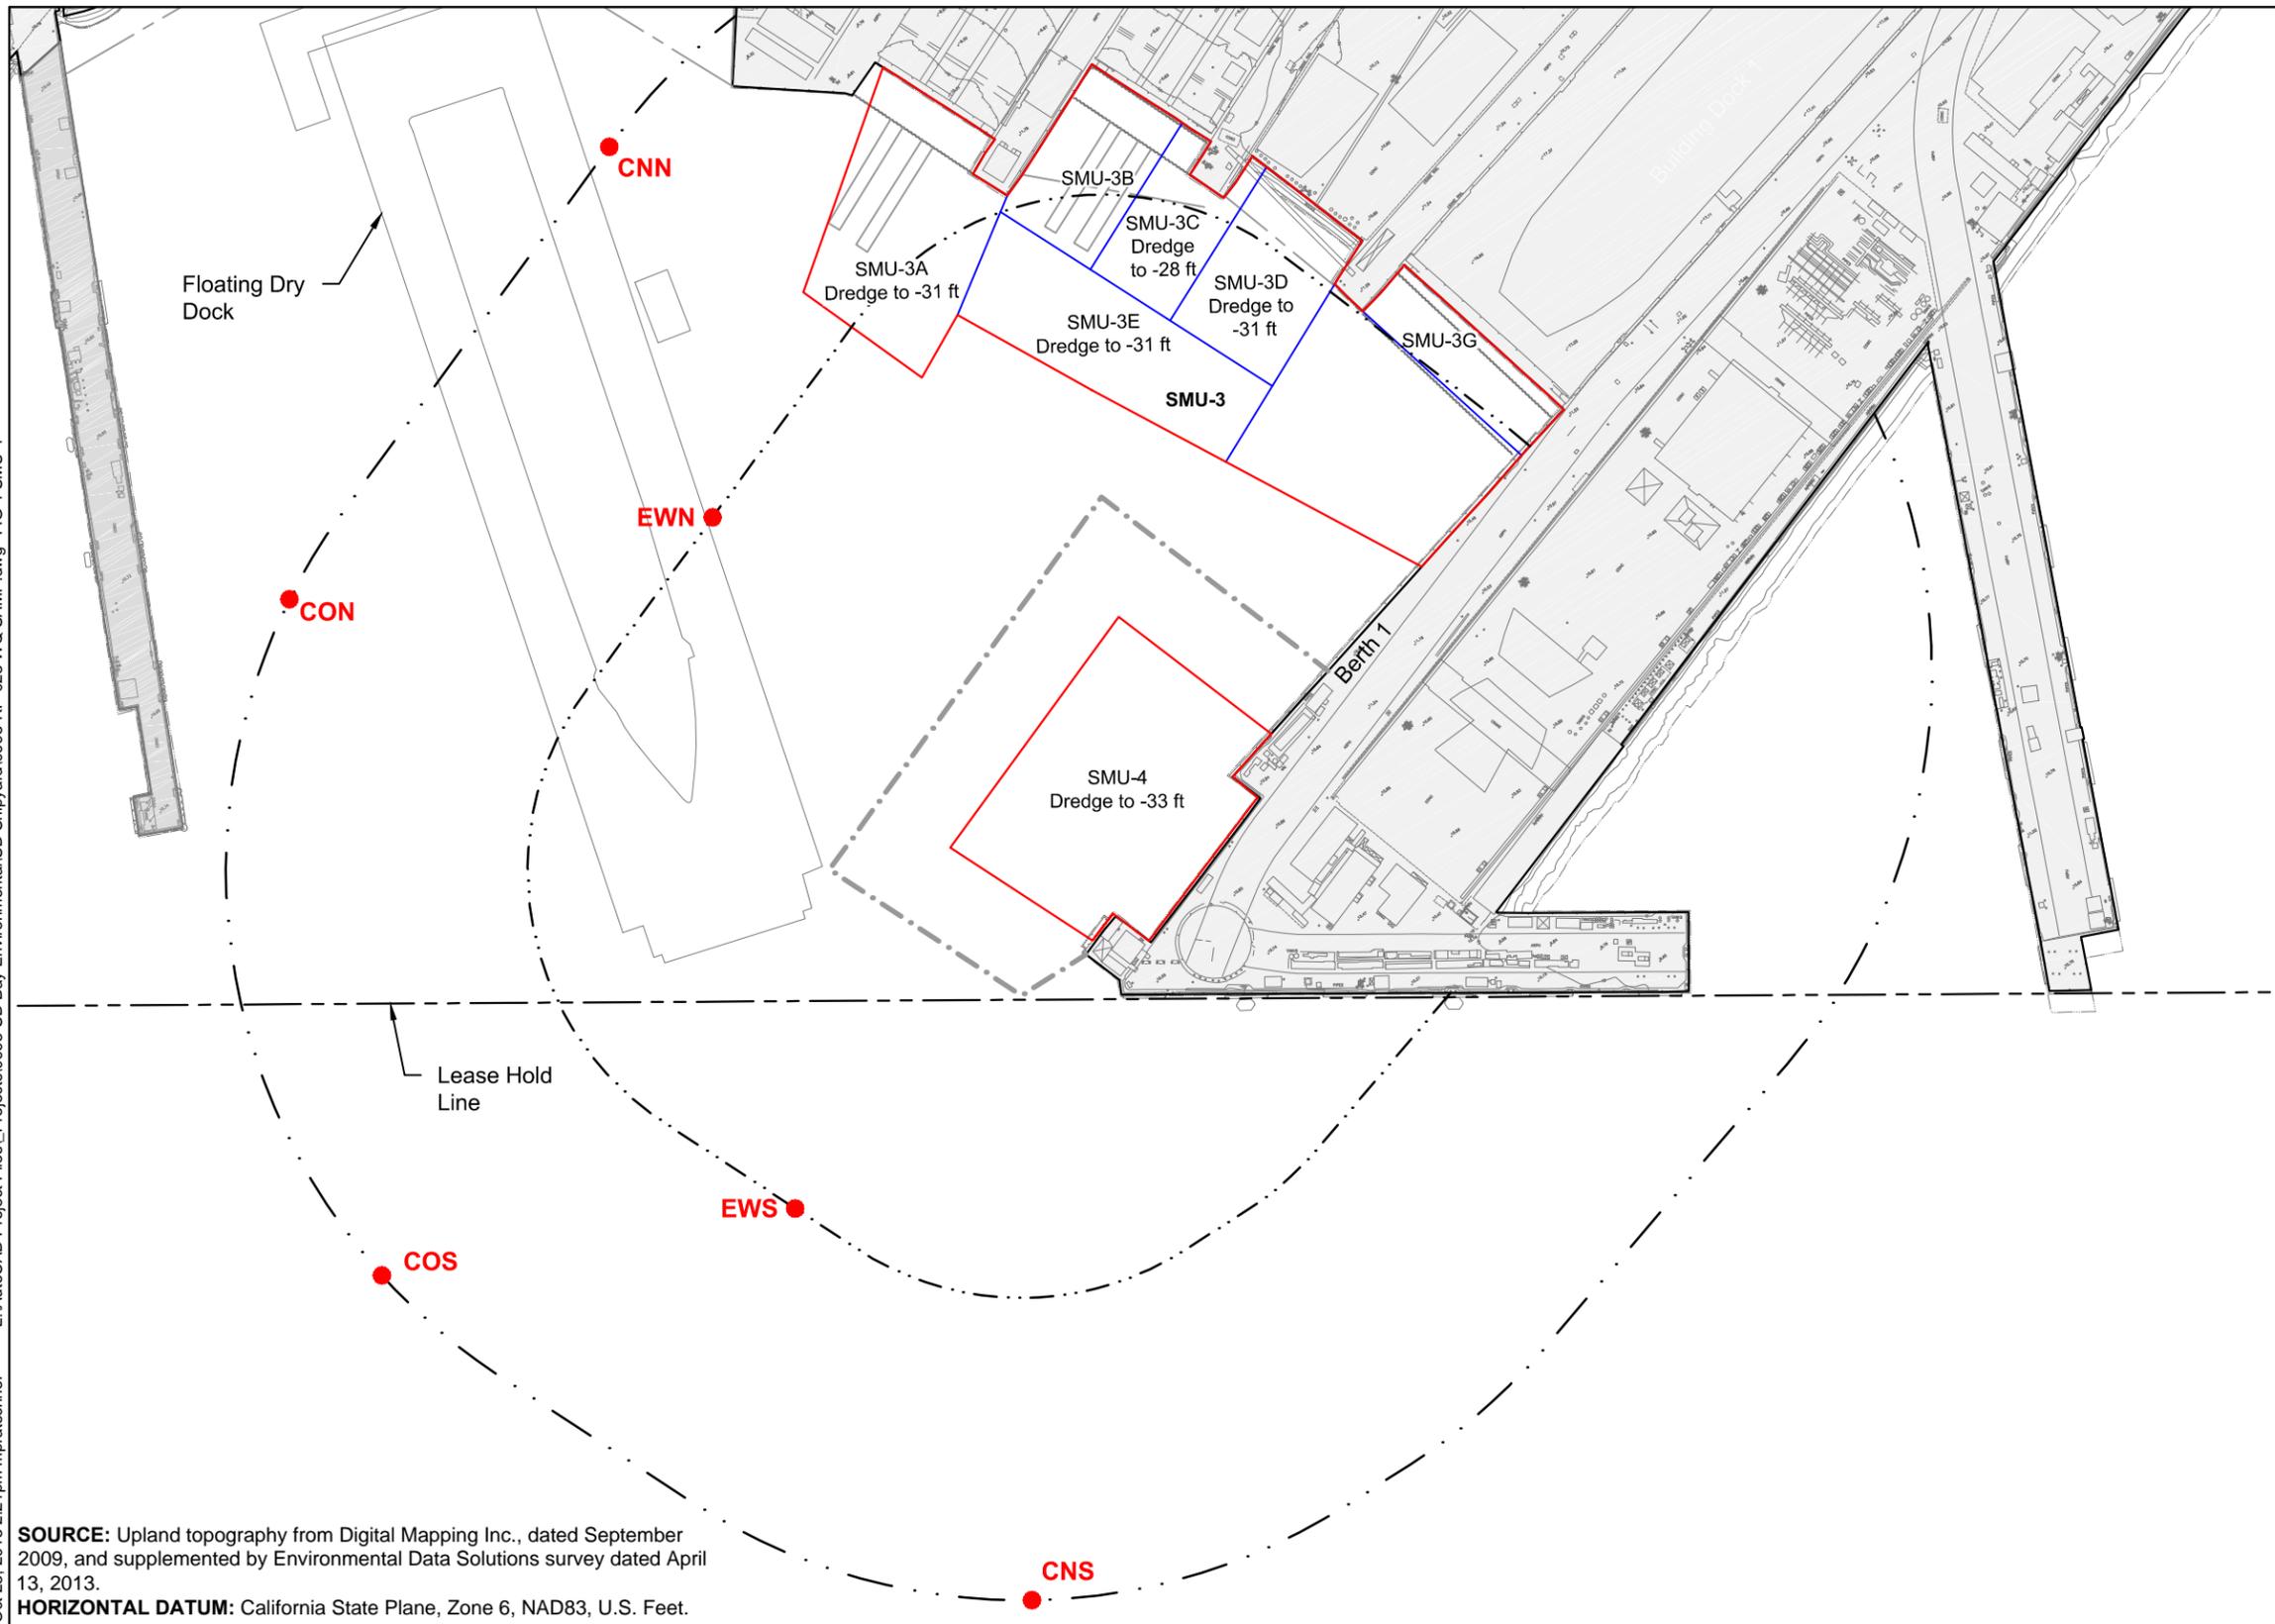
L:\AutoCAD Project Files\Projects\0995-SD Bay Environmental\SD Shipyard\0995-RP-023 WQ SAMP.dwg FIG 4 SMU-4

SOURCE: Upland topography from Digital Mapping Inc., dated September 2009, and supplemented by Environmental Data Solutions survey dated April 13, 2013.
HORIZONTAL DATUM: California State Plane, Zone 6, NAD83, U.S. Feet.
