TECHNICAL MEMORANDUM

Re: San Diego Shipyard Sediment Site – South Shipyard (Place ID 794466, Order No. R9-2013-0093) Weekly Water Column Monitoring Report: January 20 to 25, 2014

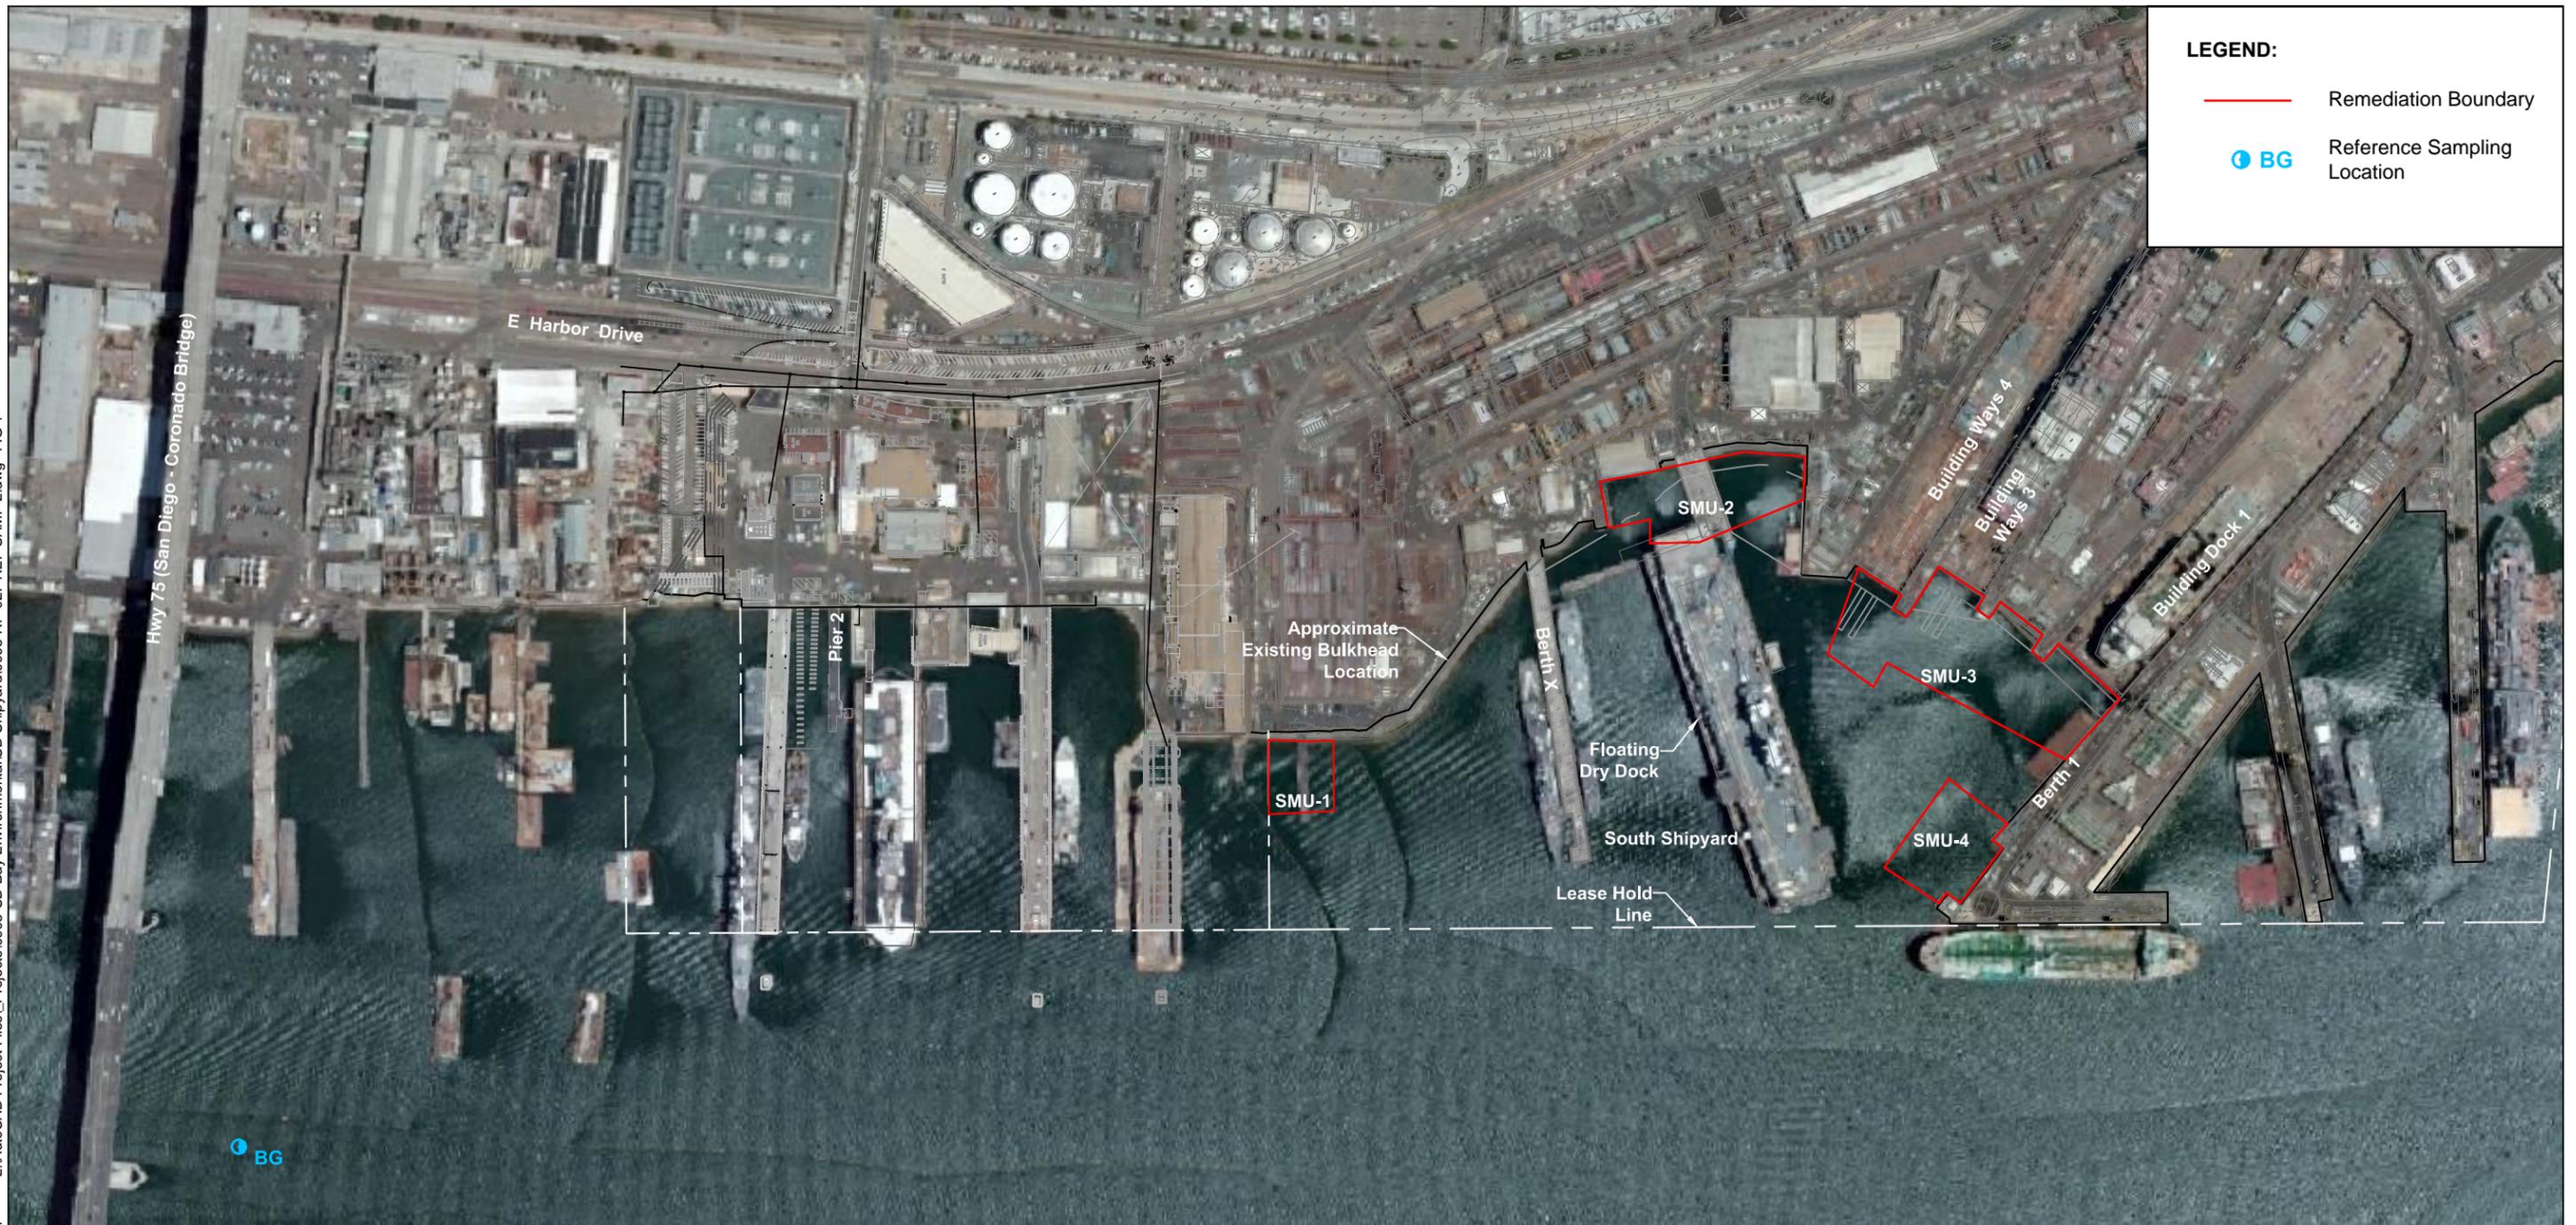
L:\AutoCAD Project Files\Projects\0995-SD Bay Environmental\SD Shipyard\0995-RP-027 REF SAMP 2.dwg FIG 1

NOTES:
 Reference Sampling Location BG
 Latitude: 32° 41.4970'
 Longitude: 117° 09.0185'

DO, pH, and turbidity were measured 10 feet below the surface at each station using a Hydrolab MS5 multi-probe sonde. Monitoring was performed at the reference station, two early warning stations, and four compliance stations. The reference station is located 1,000 feet from the remedial footprint in the direction of the ocean (Figure 1). Early warning and compliance stations are located 250 and 500 feet from the construction area, respectively. The general layout of early warning and compliance monitoring locations for Sediment Management Unit (SMU)-2 are shown on Figure 2; however, actual locations were positioned in the field relative to the construction area.¹

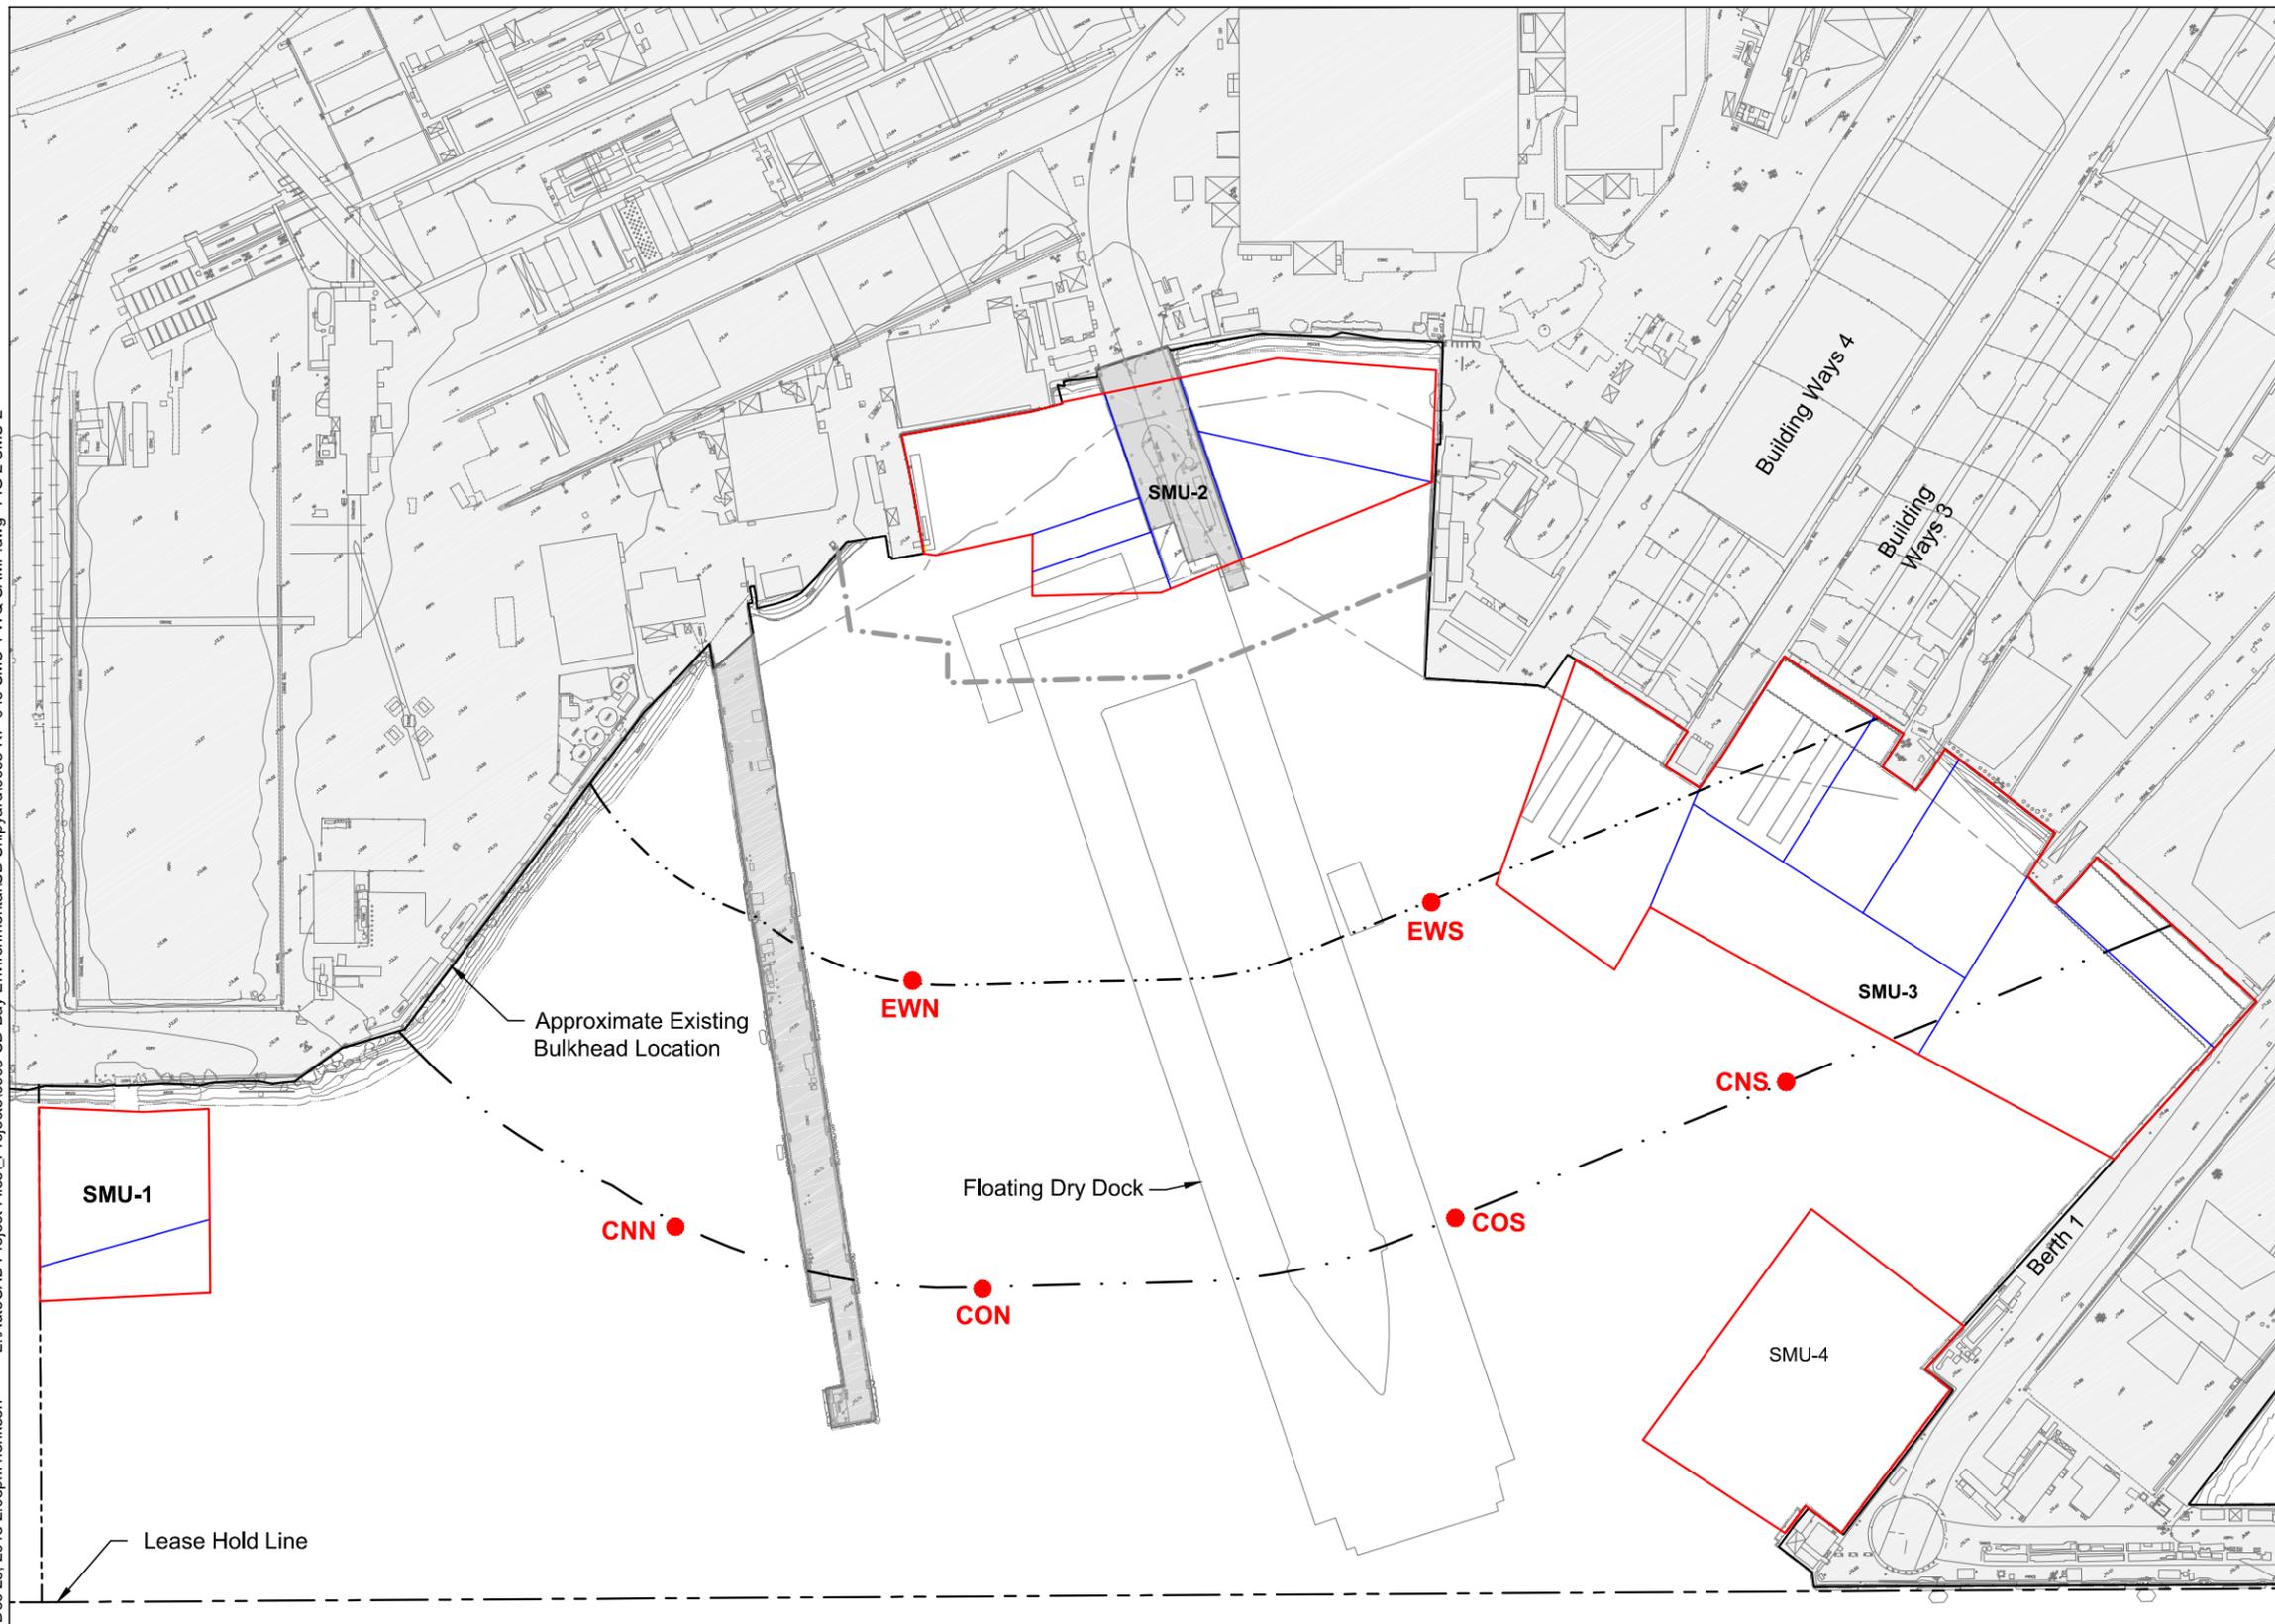
L:\AutoCAD Project Files\Projects\0995-SD Bay Environmental\SD Shipyard\0995-RP-046 SMU-1 WQ SAMP.dwg FIG 2 SMU-2
 Dec 23, 2013 2:05pm heriksen

Remediation Boundary
	Sub-SMU Boundary
	250 ft from Construction Area
	500 ft from Construction Area
	Sampling Location
	Silt Curtain
EWN	Early Warning North
EWS	Early Warning South
CNN	Compliance Nearshore North
CNS	Compliance Nearshore South
CON	Compliance Offshore North
COS	Compliance Offshore North
