TECHNICAL MEMORANDUM

Re: San Diego Shipyard Sediment Site – South Shipyard (Place ID 794466, Order No. R9-2013-0093) Weekly Water Column Monitoring Report: November 4 to 9, 2013

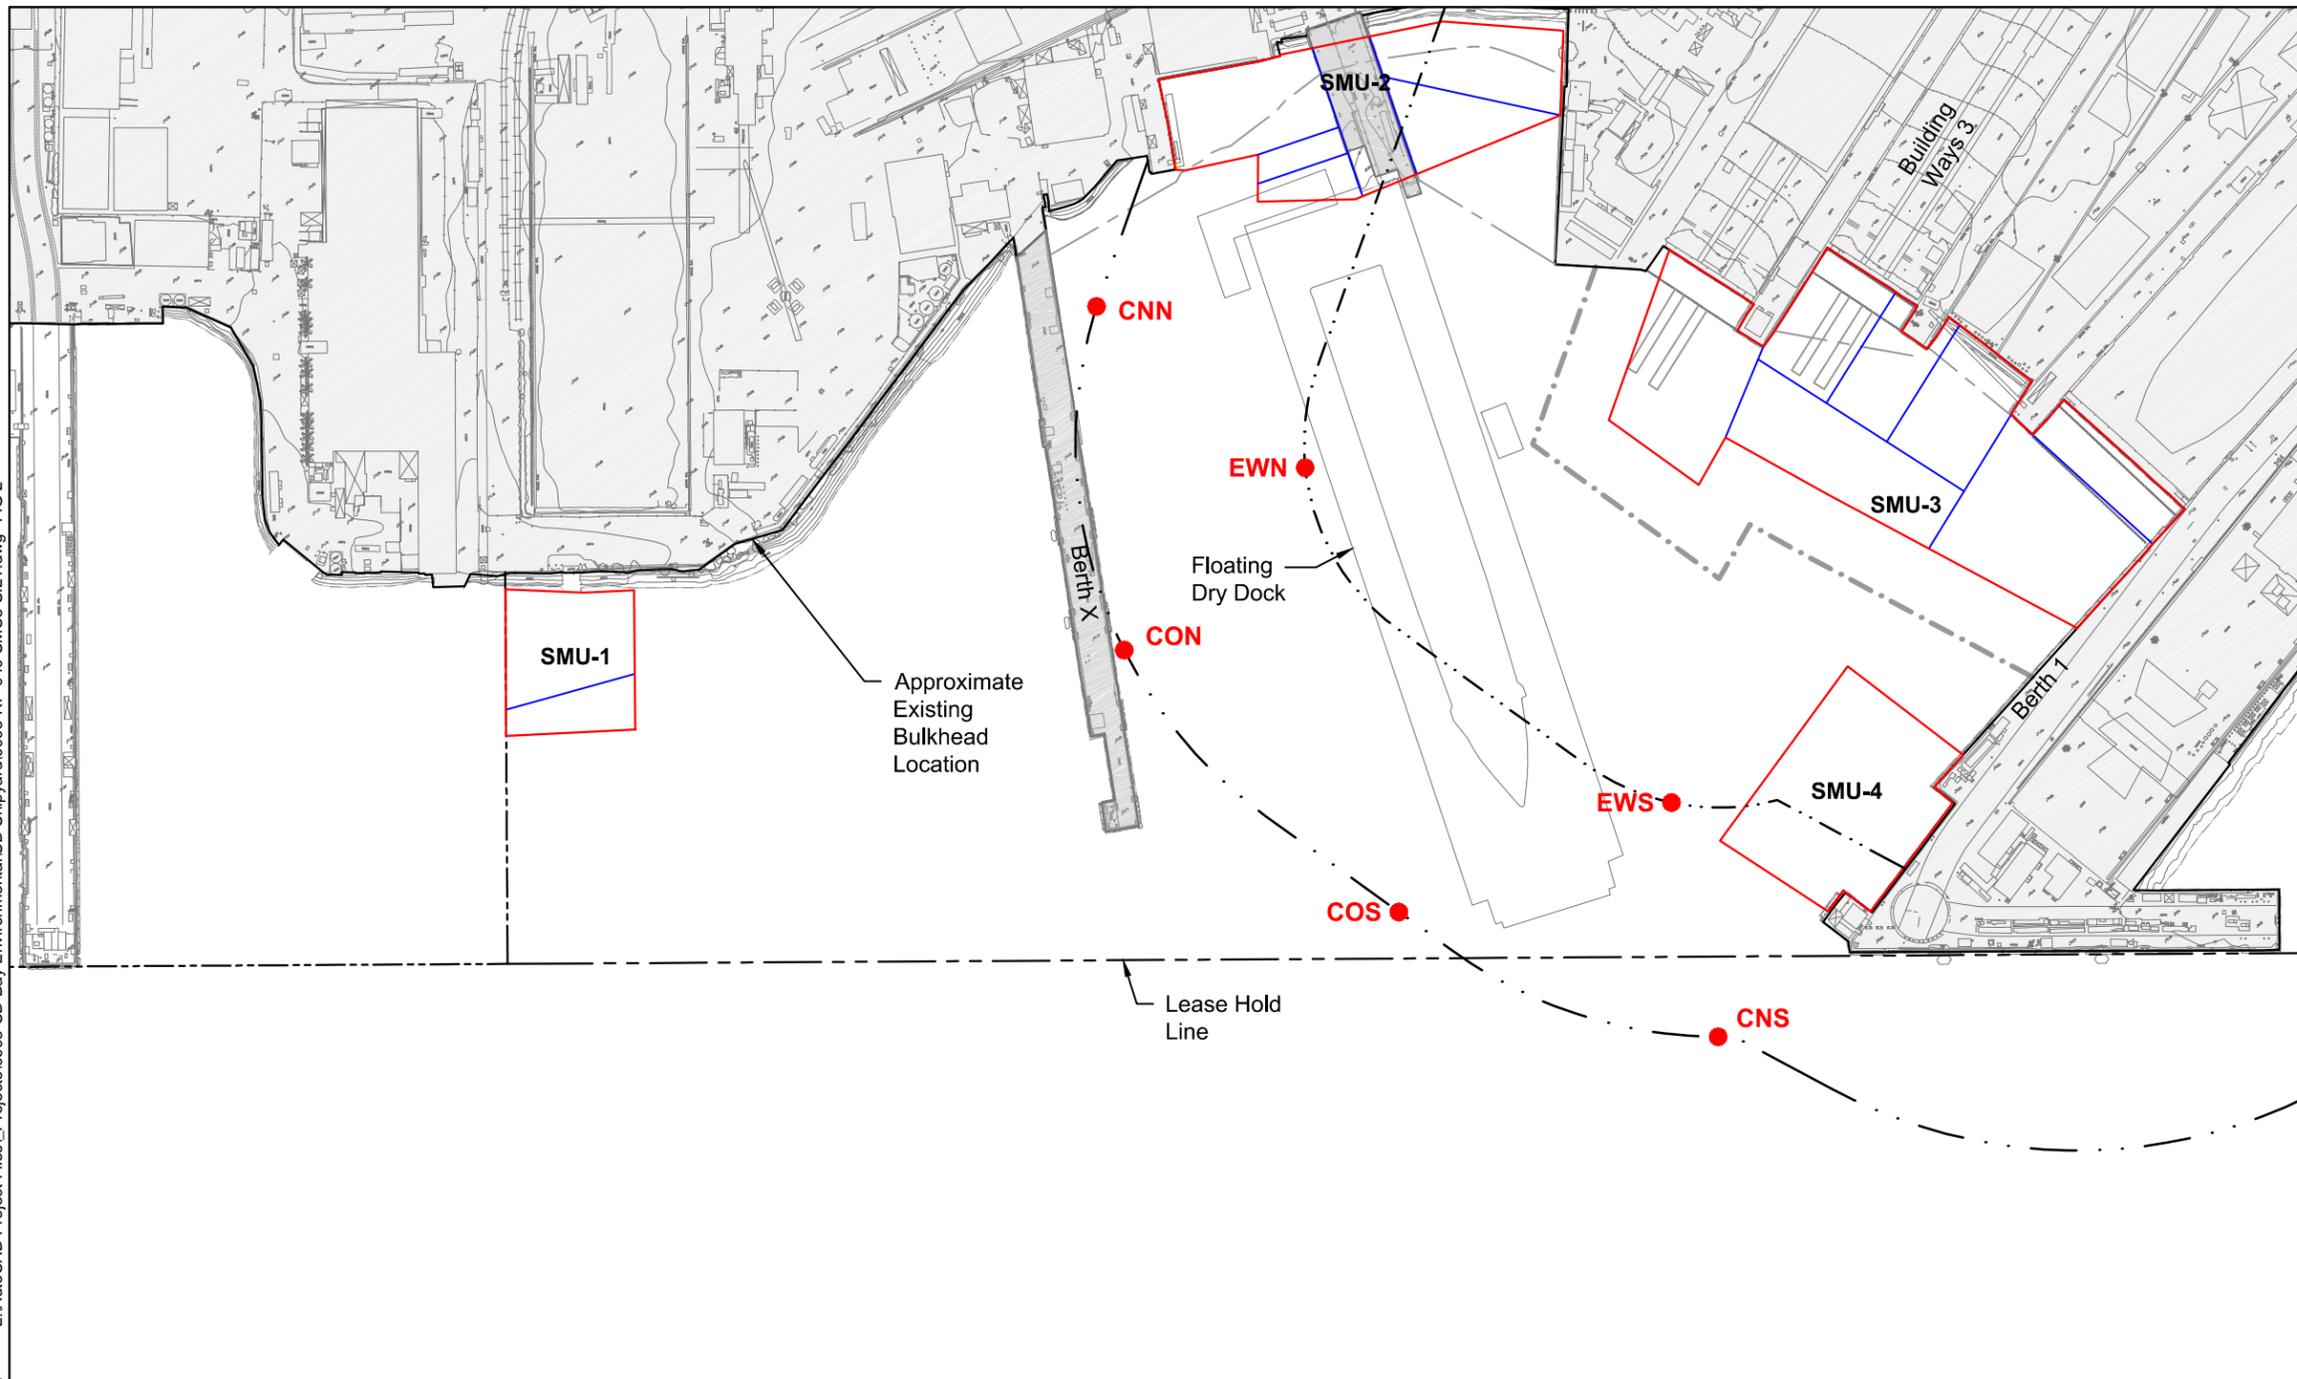
- Remediation Boundary
- Sub-SMU Boundary
- - - - - 250 ft from Construction Area
- . - . - 500 ft from Construction Area
- XXX Sampling Location
- - - - - Silt Curtain

DO, pH, and turbidity were measured 10 feet below the surface at each station using a Hydrolab MS5 multi-probe sonde. Monitoring was performed at the reference station, two early warning stations, and four compliance stations. The reference station is located 1,000 feet from the remedial footprint in the direction of the ocean (Figure 1). Early warning and compliance stations are located 250 and 500 feet from the construction area, respectively. The general layout of early warning and compliance monitoring locations for Sediment Management Unit (SMU)-3 are shown on Figure 2; however, actual locations were positioned in the field relative to the construction area.¹
