## TECHNICAL MEMORANDUM

**Re:** San Diego Shipyard Sediment Site – South Shipyard (Place ID 794466, Order No. R9-2013-0093) Weekly Water Column Monitoring Report: February 17 to 22, 2014

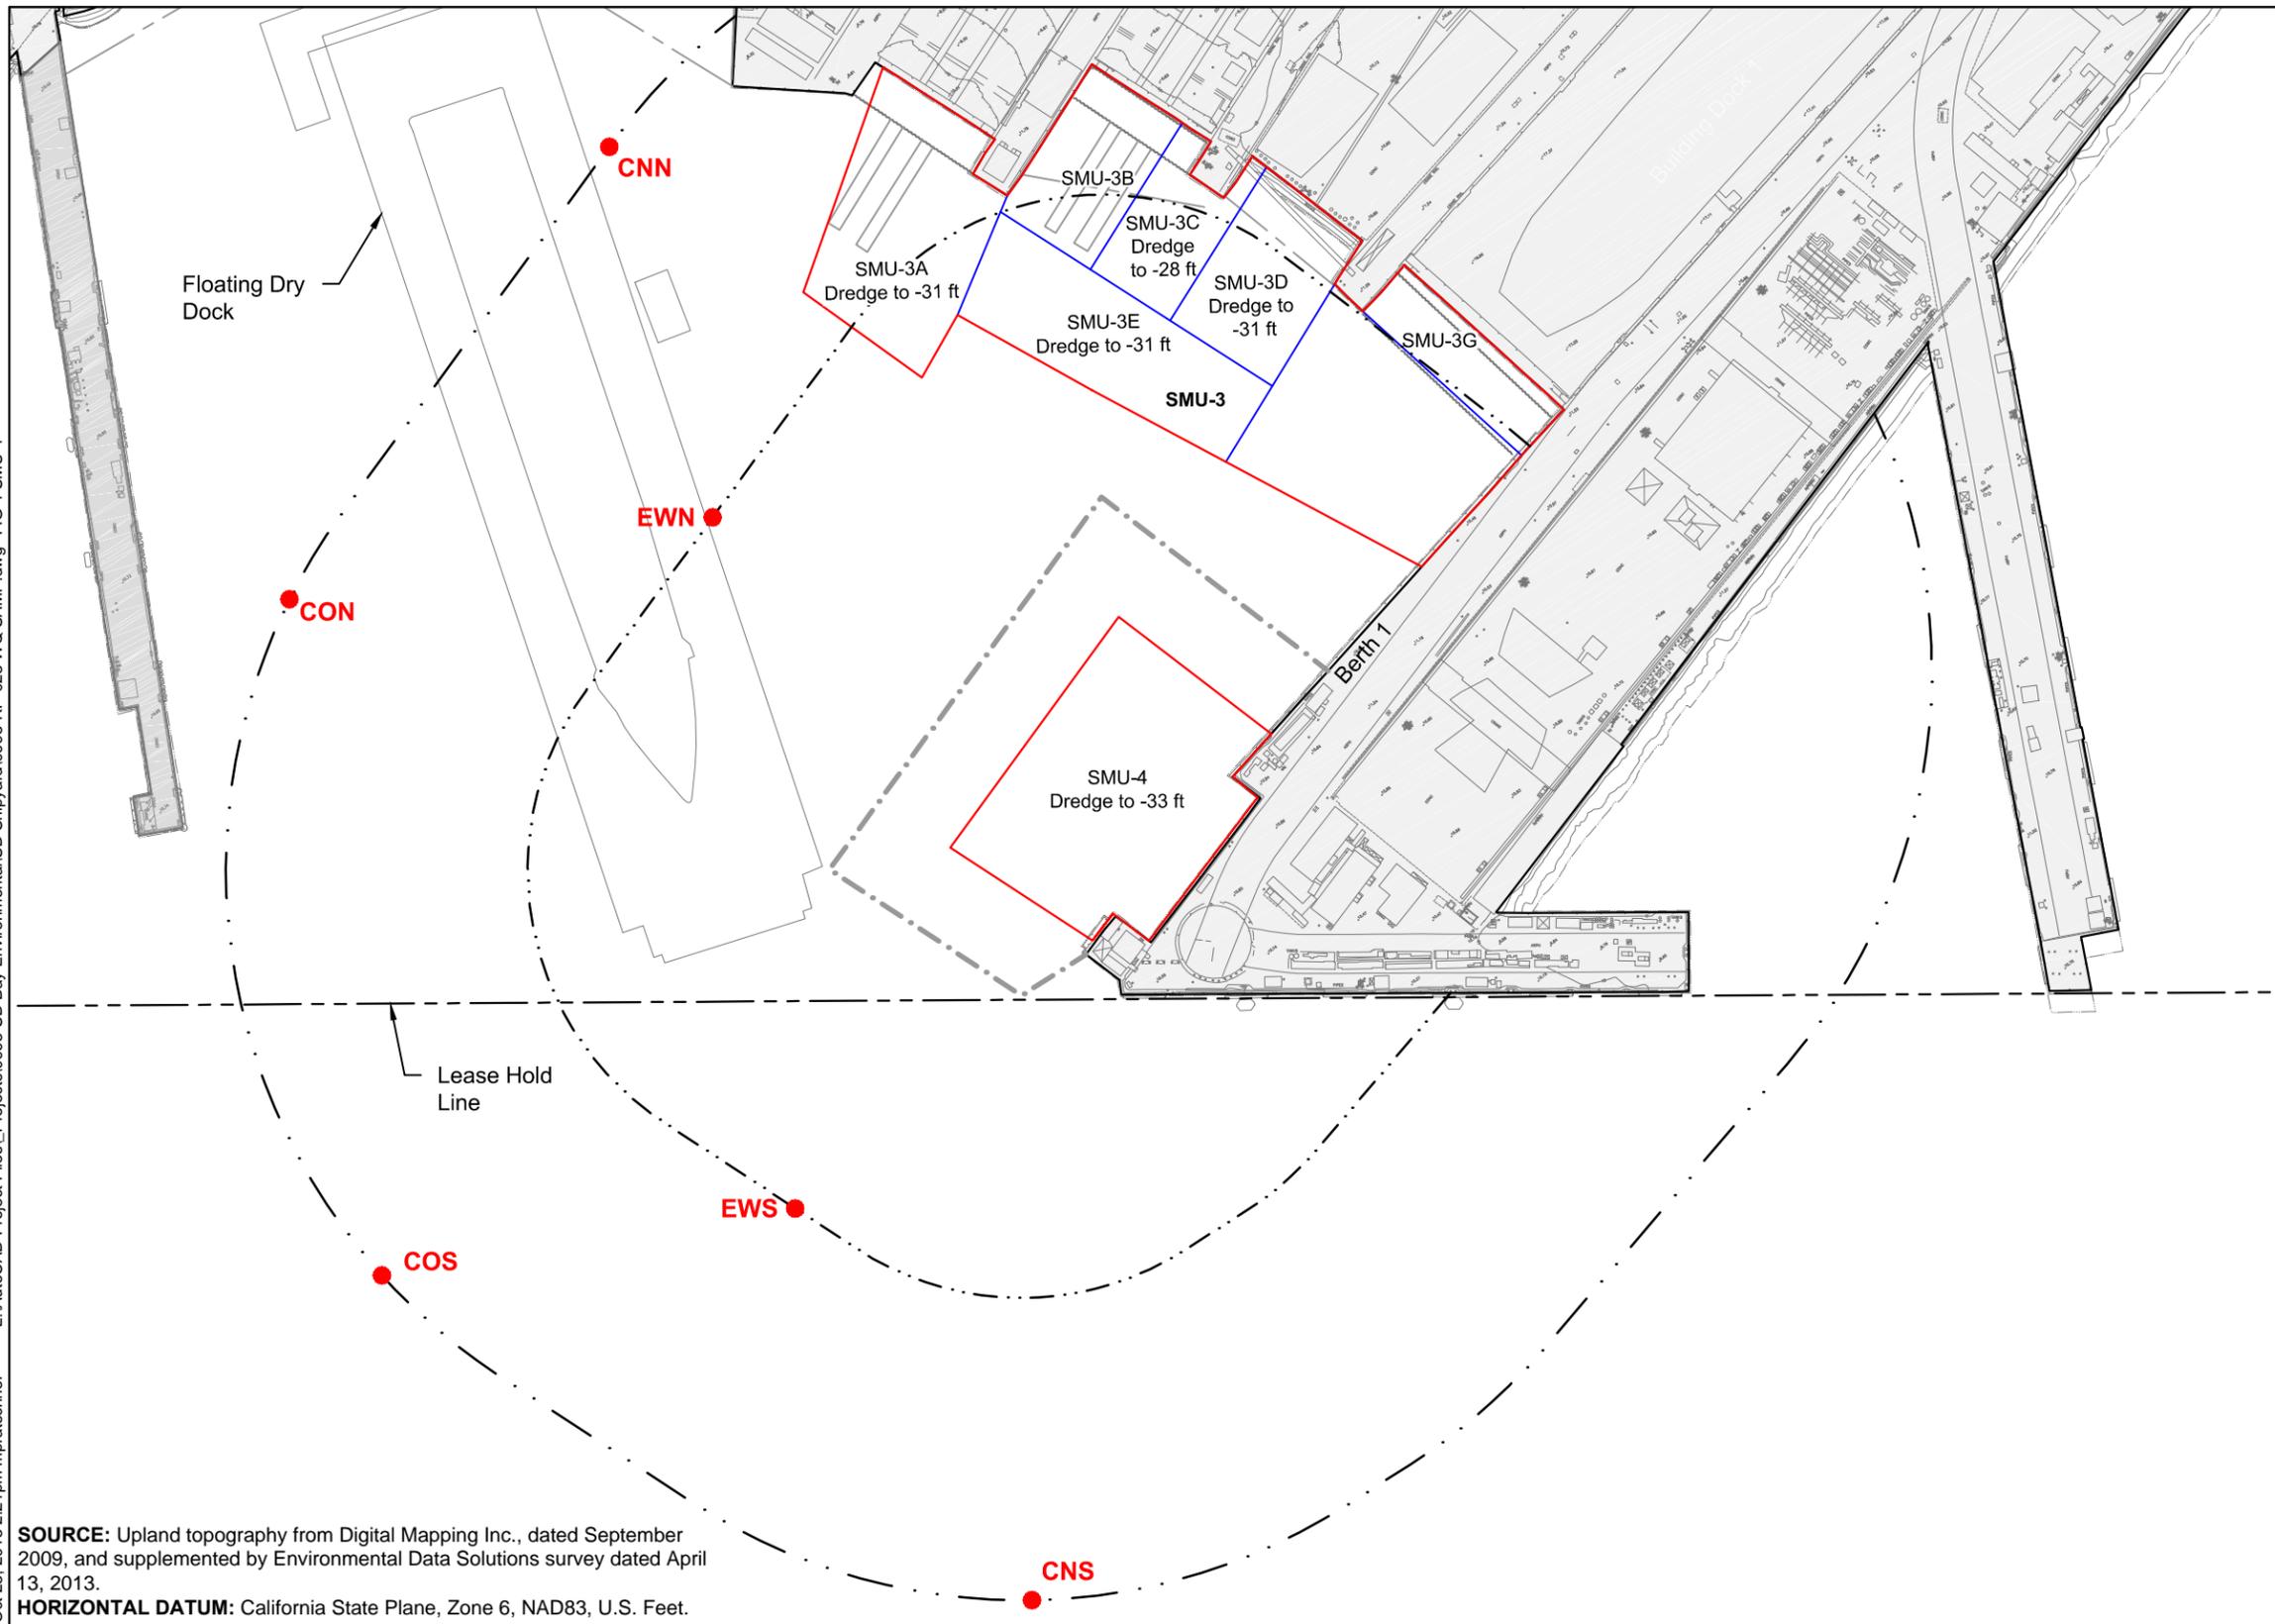
L:\AutoCAD Project Files\Projects\0995-SD Bay Environmental\SD Shipyard\0995-RP-023 WQ SAMP.dwg FIG 4 SMU-4

**NOTE:**  
 Actual sampling locations determined in the field based on the location of the construction area.
